Rapid Creek Waterways Assessment

Geomorphic Assessment

IW033600-ECH-RP_Rapid Creek Geomorphic Assessment001| Draft for comment

12 June 2015

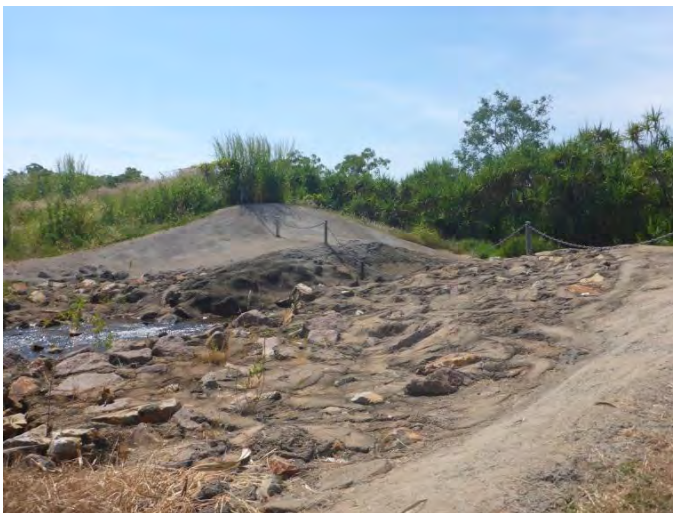
It is expected that the flood control weir may trap some sediment and debris at the beginning of the reach, reducing the potential for debris blockages to develop downstream. This may also contribute to Reach 1 erosion because the water entering the reach has a low sediment load and, therefore, a higher potential to erode the channel.

(a) Flood control weir

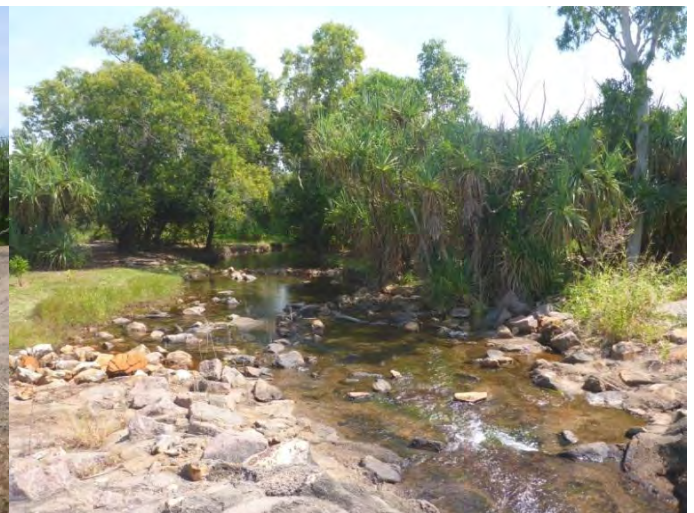
Active bank erosion and isolated bed deepening are evident over much of Reach 1. This appears to be because the creek has become naturally channelized downstream of the flood control weir (leading to increased velocities) and because the limited presence of rock bars allows the channel to be laterally active. Additionally, there is some erosion of the pedestrian path running alongside the creek. The footpath poses a risk of further erosion in Reach 1 as it efficiently captures some overbank flows and acts as a flow path in high flow events.

(b) Creek channel (immediately downstream of the Flood control weir)

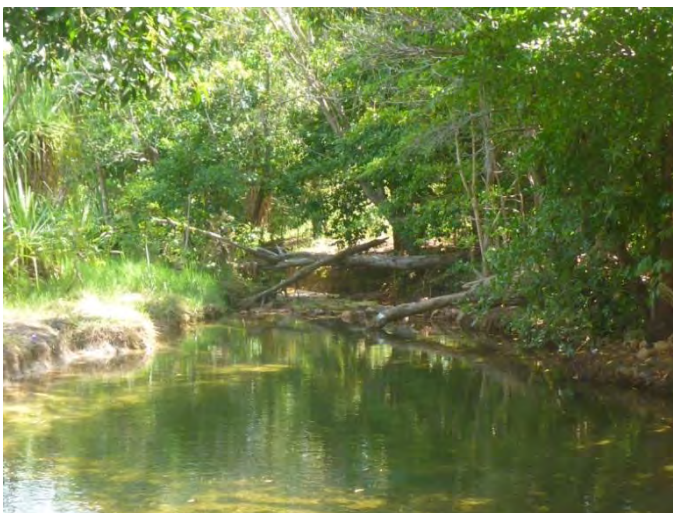
The removal of vegetation and logs from the channel in Reach 1 is not desirable, as this could decrease channel roughness, increase velocities within the channel and riparian zone, and further exacerbate bank erosion. Furthermore, many of the logs in the channel provide significant habitat for aquatic species, including fish. These logs do not have a build-up of debris around them, indicating they do not constitute significant channel blockages and will not have a significant impact on flooding.

(c) Logs across the creek channel

- Do not remove vegetation or logs. If required, some logs may be realigned to minimise localised instabilities.
- Encourage vegetation (particularly of *Syzygium angophoroides*) along the channel bank to improve long-term bank stability.
- Monitor erosion of the pedestrian path to ensure a scour channel is not formed. Consideration could also be given to re-grading the path, such that it no longer acts as a flow path in high flow events, or providing erosion protection along the path.

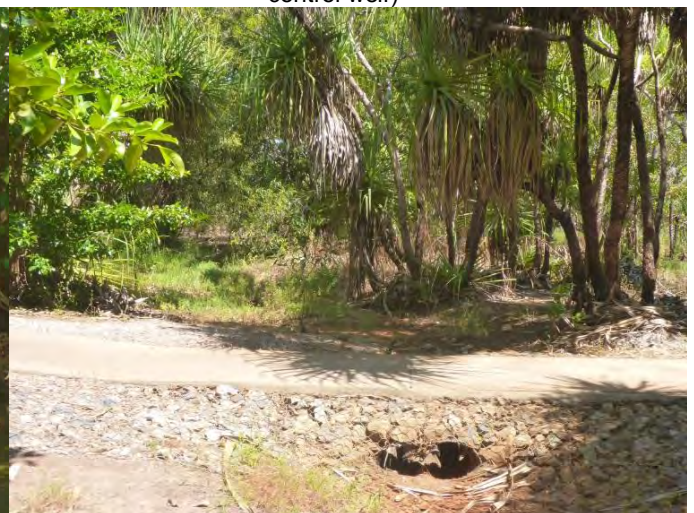
(d) Pedestrian path

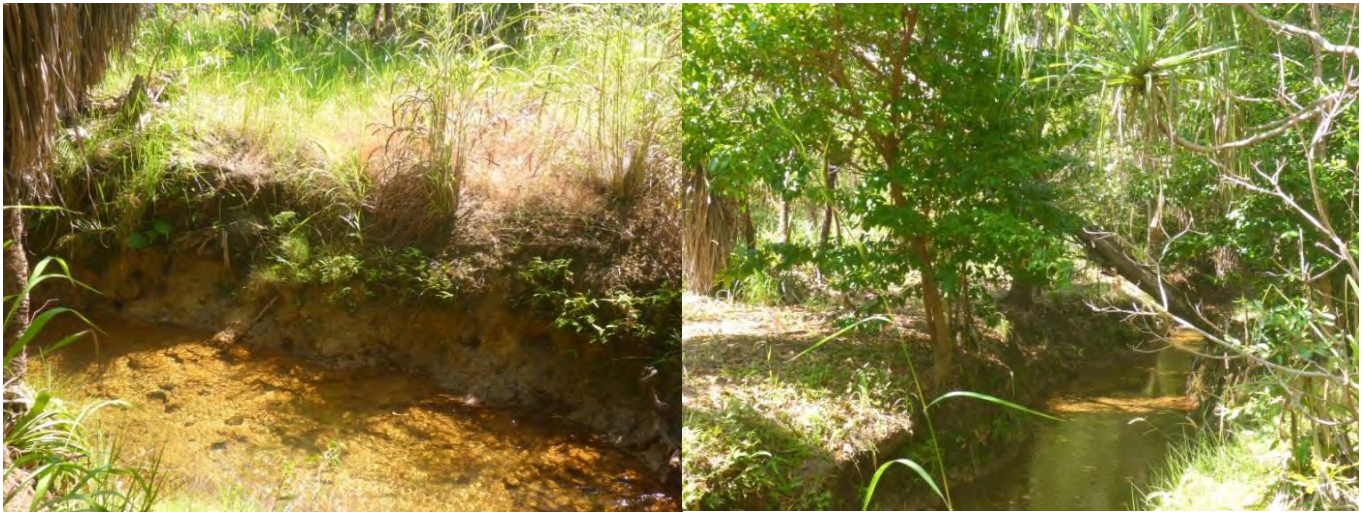
(e) Localised bank erosion

(f) Vegetation providing bank stability

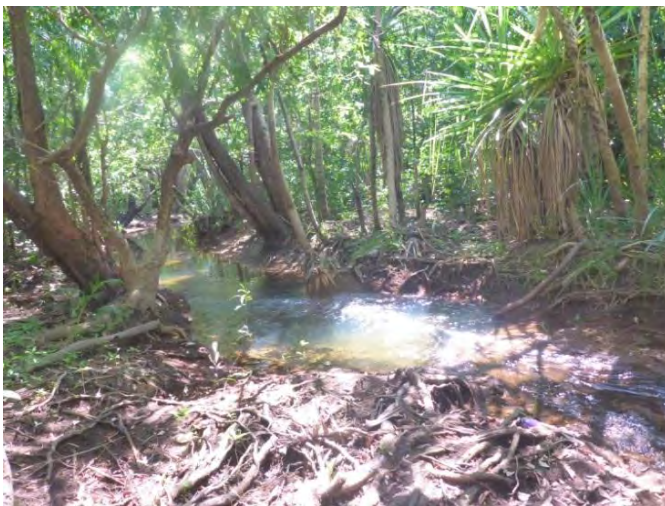
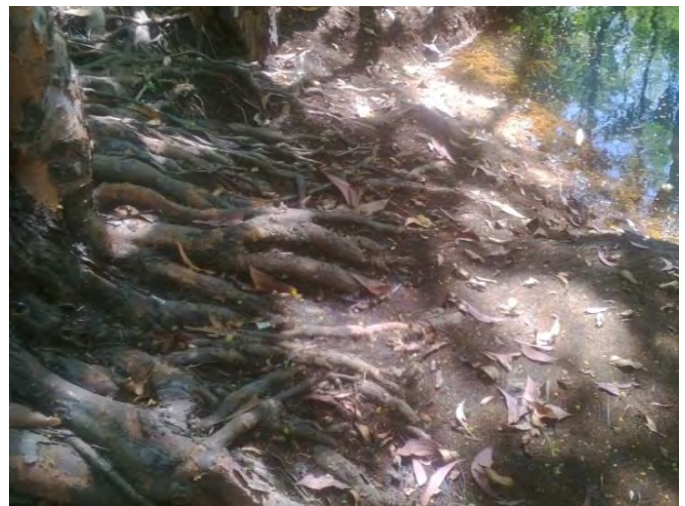
Similar to Reach 1, Reach 2 of Rapid Creek is inherently stable and has good ecological value, although the riparian zone is not particularly wide. Native trees *Syzygium angophoroides* are abundant in this reach and contribute to bank stability by creating a fibrous root mat. Rock bars are also present within the reach. This prevents bank and bed erosion due to high channel velocities.

(a) *Syzygium angophoroides* fibrous root mat

(b) *Syzygium angophoroides* fibrous root mat

- Establish a debris and silt removal program in the vicinity of culverts that is consistent with other reaches. This can be achieved in the Rapid Creek Condition Maintenance Plan.
- Investigate opportunities to manage sediment inputs from the drain contributing to the blockage at Kimmorley Bridge.
- Investigate options to remove the small pipe crossing upstream of Henry Wrigley Drive, including directional boring to lower the pipe beneath the creek channel
- Do not remove *Syzygium angophoroides* and instead promote its growth

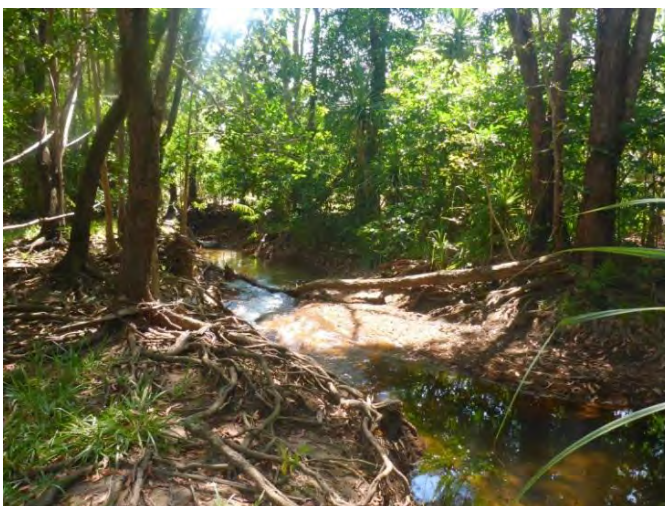
There is little debris collected on fallen trees and logs, indicating that they do not contribute to significant blockages of the cross section. Additionally, there are some minor mid-stream islands present which appear to be stable, like the banks of the main channel.

(c) Logs (not constituting a significant blockage of the channel cross section)

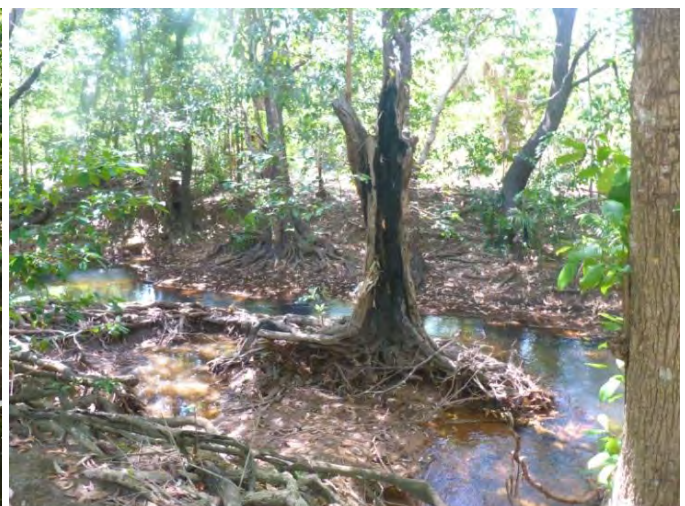
(d) Mid-stream island

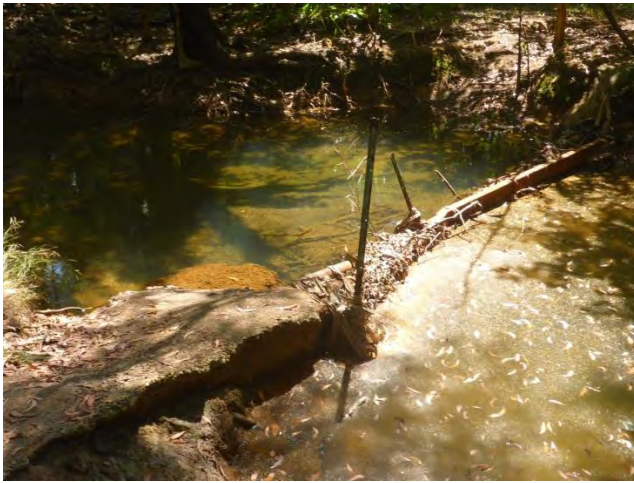
A corroded galvanised pipe/utility crossing is located at water level upstream of the Henry Wrigley Drive culvert (refer to Figure 3-2 (e)), and creates a minor blockage. It is not likely to have any significant impact on flooding. However, it does capture some debris.

(e) Pipe crossing upstream of Henry Wrigley Drive

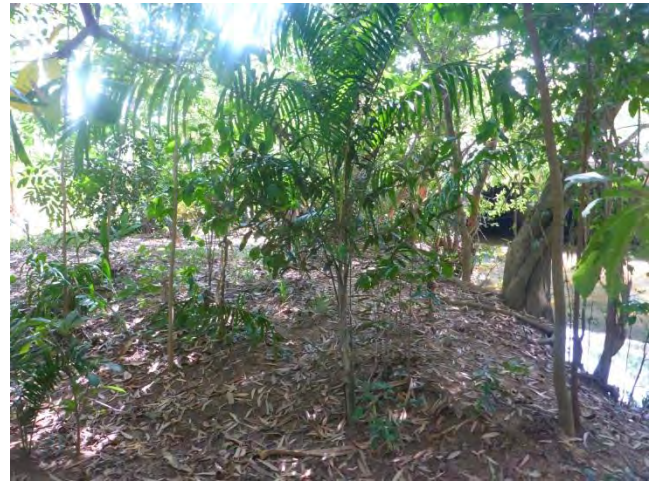
Furthermore, a large drain enters the creek from the west immediately upstream of Kimmorley Bridge. It appears that this outfall has contributed a sediment load to the location which, in turn, has become heavily vegetated. At present, the vegetated bar partially blocks the approach to the Kimmorely Bridge (culvert). This has the potential to impact the efficiency of the crossing and increase upstream flooding. Therefore, the outfall and surrounding area should be regularly maintained, like the Henry Wrigley Drive culvert, and sediment and vegetation should be removed. A consistent distance for debris relocation/removal at the Henry Wrigley Drive culvert and Kimmorley Bridge is provided in Section 7.

(f) vegetation on deposited silt (immediately upstream of Kimmorley Bridge)

There may also be potential to construct a sediment trap in the drain to limit sedimentation immediately downstream in Rapid Creek.

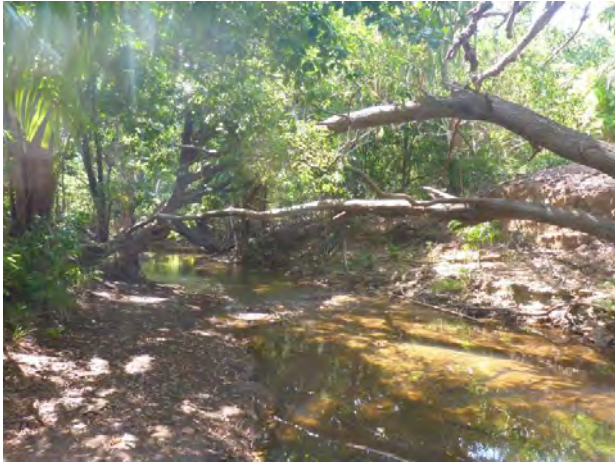
Like Reach 2, *Syzygium angophoroides* is present throughout Reach 3 and appears to create a fibrous root mat which significantly aids in bank stability. There is also little debris on logs, which are not considered to contribute to significant blockages of the creek cross-section.

(a) Typical creek section with fibrous root mat creating bank stability

- Maintain vegetation (and potentially promote further vegetation) to improve the visual amenity and ecological values of the reach.
- Maintain outfalls and assess the potential to provide gross pollutant traps (to remove gross pollutants from the creek channel).
- Monitor and maintain creek blockages in the vicinity of the gauging station (if deemed necessary for efficient gauging)
- Establish a debris removal program in the vicinity of bridges consistent with other reaches. In particular, maintain an open channel 10-20m downstream of Kimmorley Bridge to maintain the structures efficiency (as discussed in Section 3)

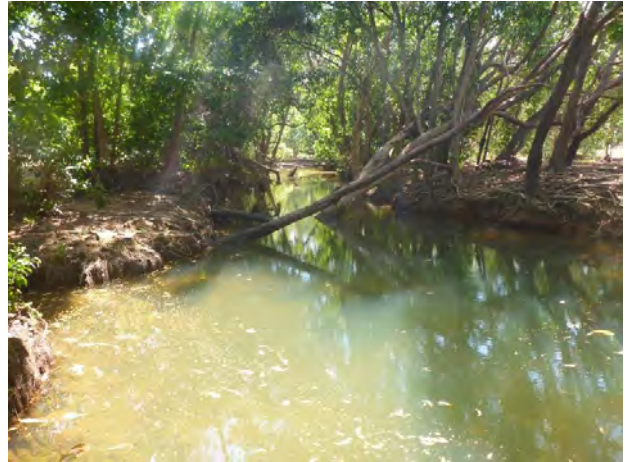
(b) Fallen trees (without captured debris)

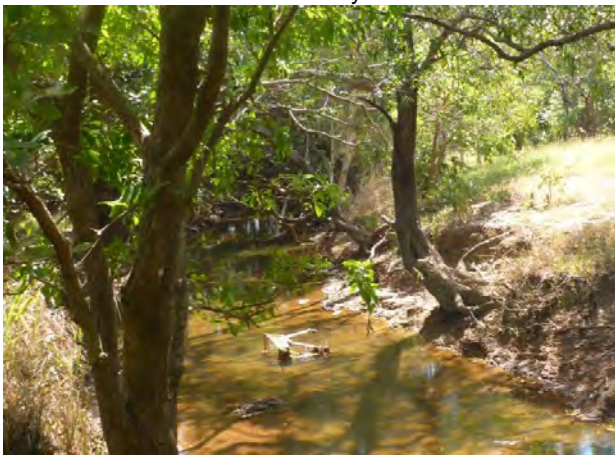
The creek appears relatively stable compared to other reaches. This appears to be due to the regular occurrence of rock bars maintaining bed and bank stability and limiting lateral erosion. As a result, the removal of vegetation within this reach may not cause significant instabilities. However, it would impact the ecological and visual values of the reach, the importance of which are demonstrated by the presence of the pedestrian and bicycle path. The visual amenity of the creek is impacted by the presence of rubbish and debris in a number of locations. This is due, in part, to a number of drainage outfalls in the reach which drain directly into the creek channel. These outfalls are stable. However, gross pollutant traps may improve the visual amenity and water quality of this reach.

(c) Creek section (with rubbish present)

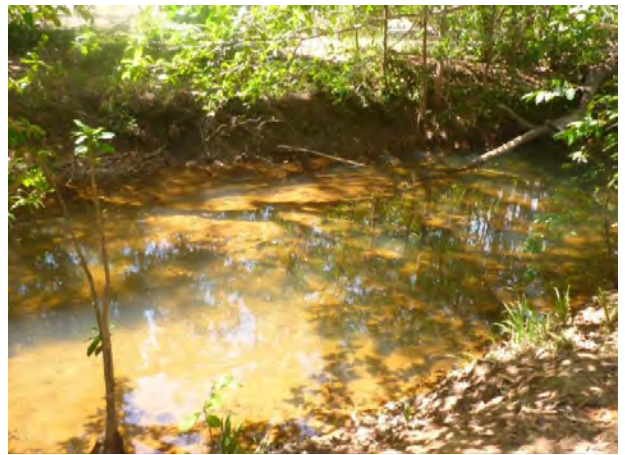
(d) Rock bars

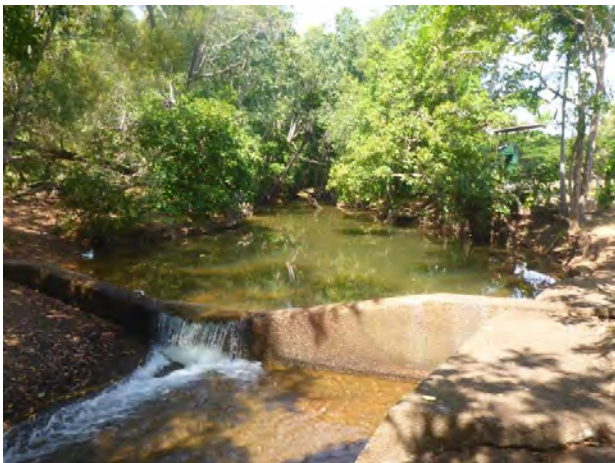
The gauging station appears to be stable. However, if trees are not maintained in the vicinity of the structure, localised unstable hydraulic conditions may affect the approach flows to the weir and impact the ability to accurately gauge flow.

(e) Gauging station

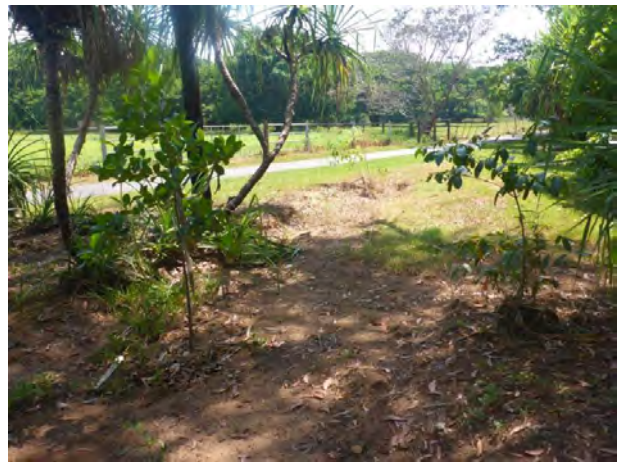
(f) Pedestrian and bicycle path

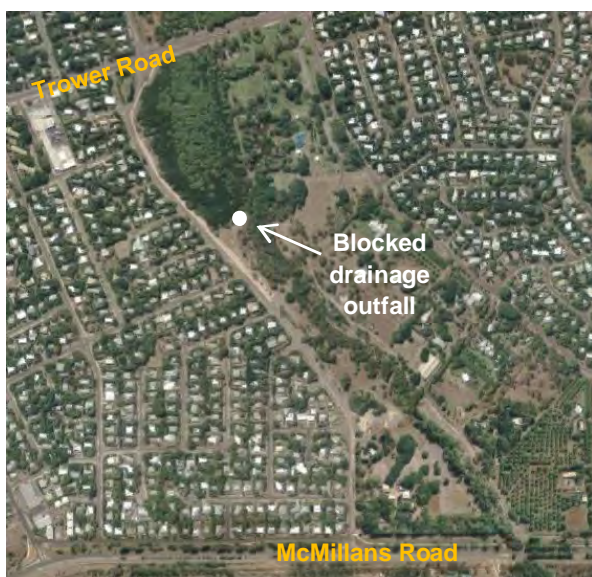
Figure 5-2: Location of the blocked drainage outfall in Reach 4

- Develop a plan that considers reducing vegetation blockages. This can be done as part of the Rapid Creek Condition Maintenance Plan.
- Control headward erosion at the drainage outfall
- Reconstruct the elevated drainage outfall pipe that restricts the floodplain width in this location and increases stream power in the channel. Alternatively, armour the creek banks with vegetation and rock protection

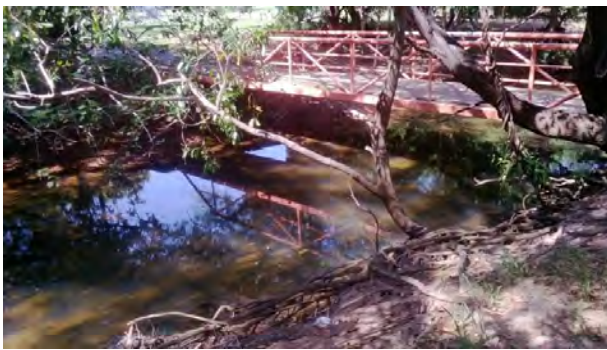
(a) Water Gardens Footbridge (looking upstream)

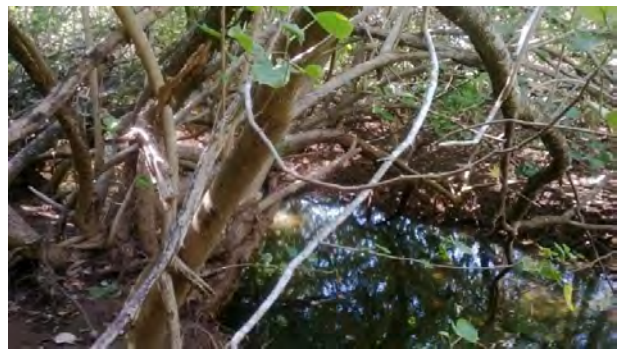
- a lack of observed rocky outcrops (particularly relative to Reach 3);
- localised mid-stream vegetation blockages which direct flow to the eroding banks and cause sediment deposition in locations such that further erosion occurs; and
- the blocked drainage outfall causing an increase in velocity in the immediate vicinity of the crossing and downstream headward erosion.

(b) Dense vegetation causing localised blockages

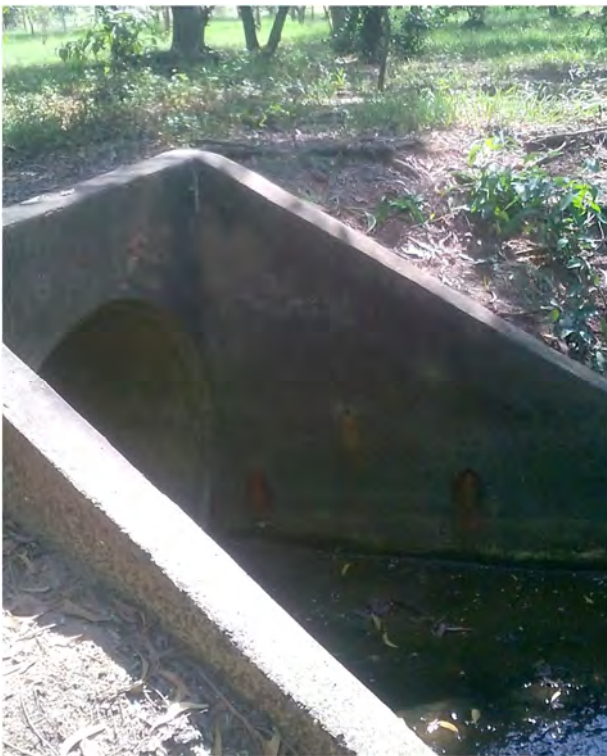
(d) blocked drainage outfall

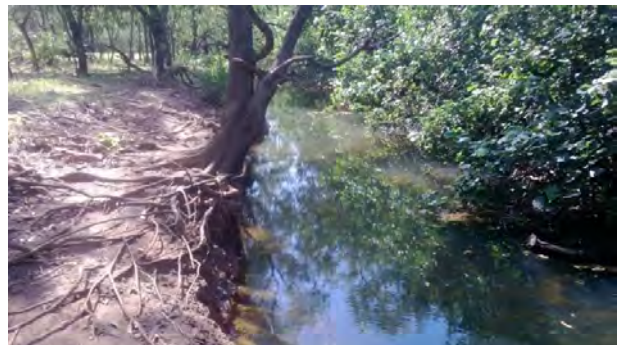
Significant lateral bank erosion is evident over much of Reach 4. This erosion appears to be caused by a number of issues including:

(c) bank erosion (as a result of the blocked drainage outfall)

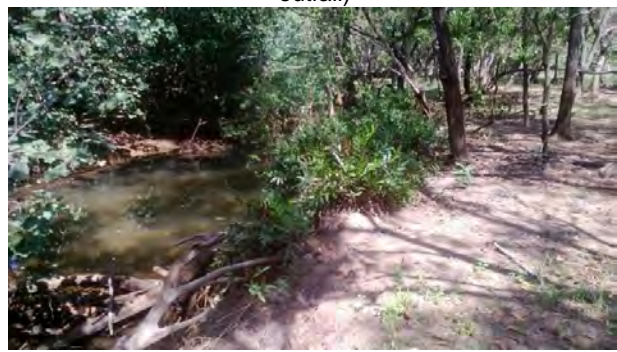
It appears some revegetation has been attempted in locations throughout the reach with limited success. To improve the stability of the reach, it is necessary to develop a plan to reduce vegetation blockages and redesign the drainage outfall or, alternatively, armour the bank with vegetation and rock protection.

(e) Attempted revegetation

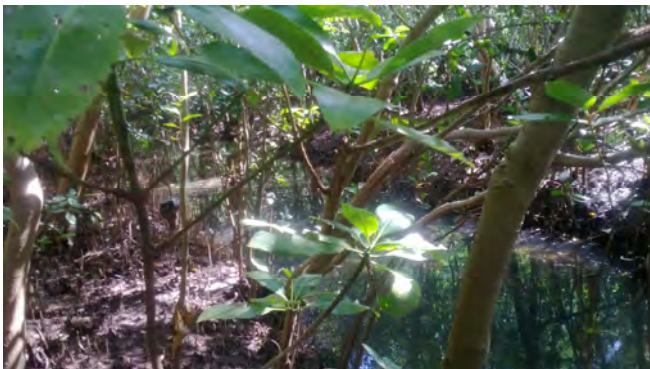
It is likely that Mangrove will remain the dominant vegetation type throughout Reach 5. Attempts to control Mangrove growth are likely to be unsuccessful as the extensive presence of Rhizome will lead to regrowth.

(c) Typical vegetation (with Rhizomes)

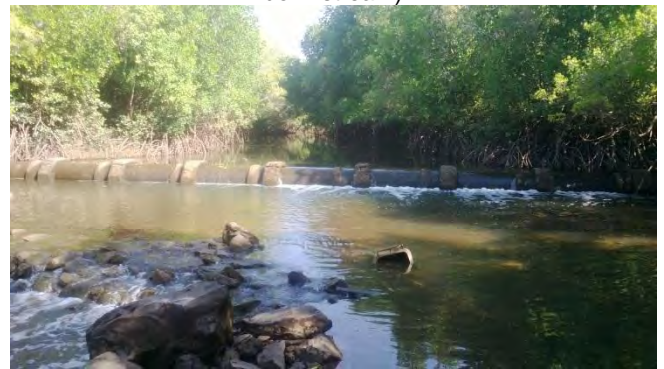
A major sewer crossing blocks the creek part way downstream of Trower Road. The crossing is elevated approximately 900mm above the creek bed. The removal or redesign of the crossing is likely to have a very large economic cost, and is unlikely to significantly increase channel capacity due to the limited cross-sectional area of the creek in this location. Removal or reconstruction of the sewer may increase the gradient of the channel upstream and, therefore, increase the creek's capacity to pass flows. However, the effects of this would not be seen upstream of Trower Road because the Trower Road bridge is a major restriction point for the creek. Furthermore, removal of the sewer will not reduce the risk of flooding the urban zone.

(d) Sewer crossing (looking upstream)
