# DO TREES IN RAPID CREEK CONTRIBUTE TO FLOODING?

**RAPID CREEK LANDCARE GROUP, SEPTEMBER 2013**

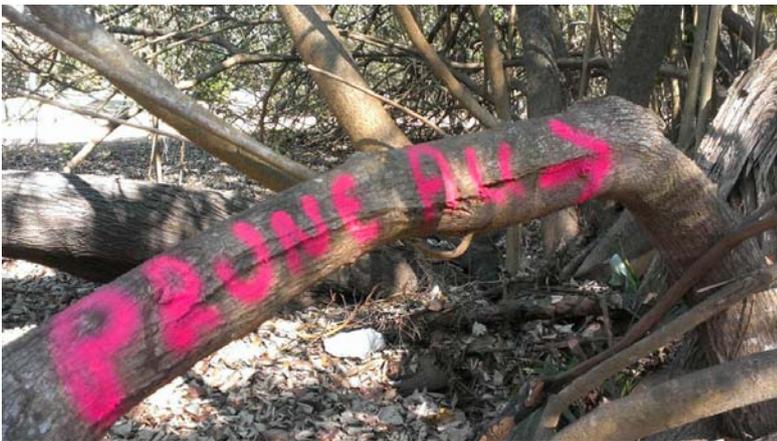
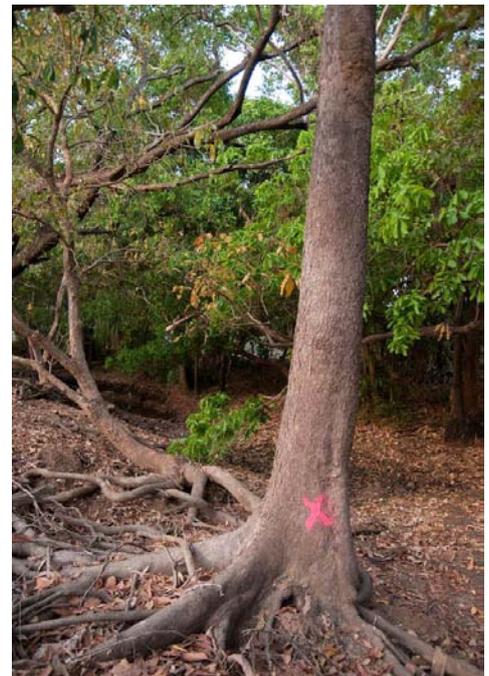
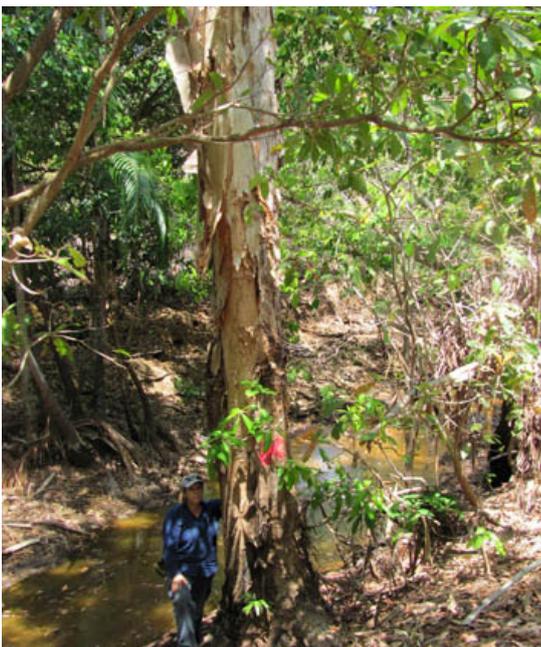
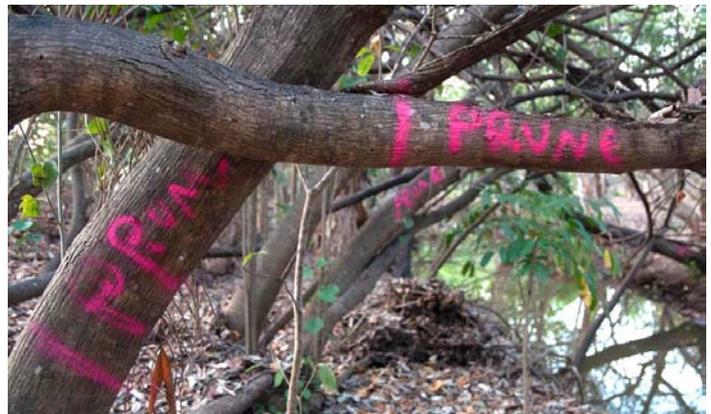
We seriously question how these pink crosses, dots and words can be interpreted as 'data collection':

- What is the rationale and methodology behind the survey?
- Why only survey this section of the creek?
- Why use the words PRUNE and PRUNE ALL?
- Why use such an invasive method as paint instead of flagging tape or GPS points?

On Monday 23 September members of the Rapid Creek Landcare Group noticed about 100 trees at Rapid Creek marked with pink paint. It appeared that all trees in the monsoon forest channel between McMillans Road and Trower Road were painted. Many trees had large pink crosses on them, some smaller trees had pink dots, some had the word PRUNE written next to a line around a branch, and others had the words PRUNE ALL written. Young trees, mature trees, live trees and dead trees were all painted. The trees are part of the important monsoon forest that lines Rapid Creek.

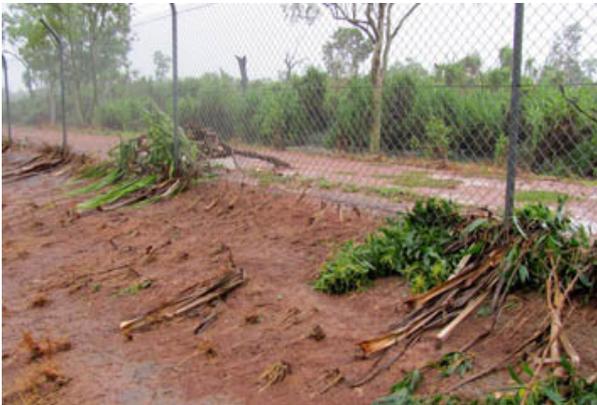
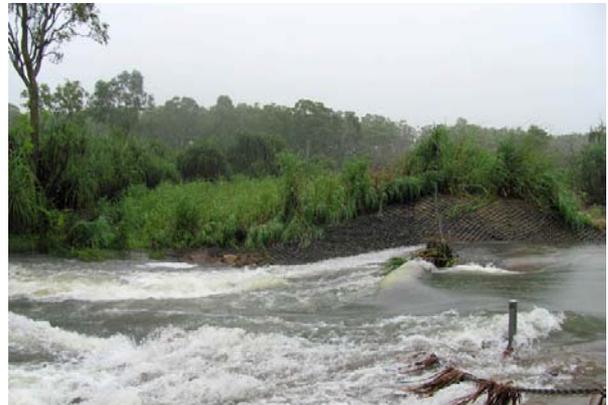
*Photos taken on the morning of Cyclone Carlos on 16/2/2011; the left photo shows the bank of the flood mitigation weir with debris demonstrating the water had come over the top; the right photo shows the creek channel coming through the weir (NB the flood peak had occurred the previous night)*

The stream gauge on Rapid Creek downstream of McMillans Road recorded a peak height of 3.74 metres during Cyclone Carlos; the highest peak recorded before this was 3.67 metres in March 1977 (Saunders *et al.* 2013). There is a flood mitigation weir on Defence and Airport land that controls flow from the large upper catchment of Rapid Creek, including Marrara Swamp. It was constructed in 1985. On the night the houses flooded the water came up over the banks of the weir, effectively negating its flood mitigating effect. We have not been able to establish if this has ever happened before.

**This was an extreme weather event estimated to be a 1:140 year flood!**
