Factual Report on
Additional Geotechnical Investigation

Proposed Rapid Creek Flood Mitigation
Corner of Henry Wrigley Drive and McMillans Road,
Marrara, NT

Prepared for
Jacobs Group (Australia) Pty Ltd

Project 78245.02
December 2017

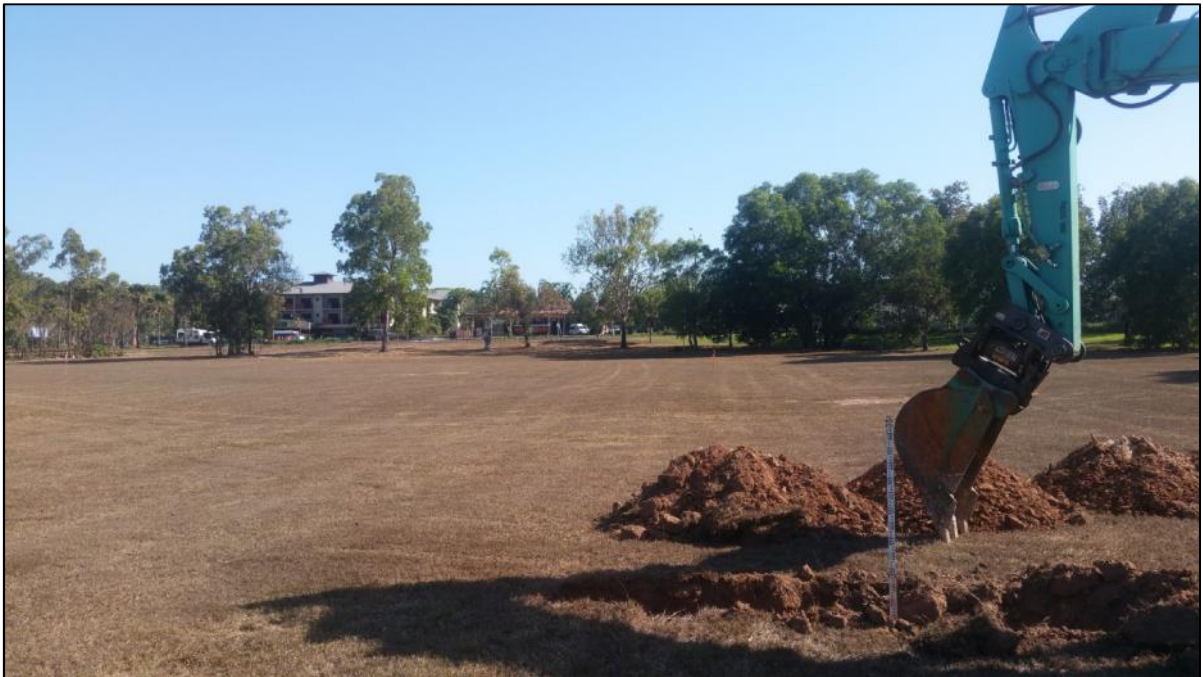
Figure 1 – North-eastern area of the site, looking north

Figures 1 to 4 below show the site conditions at the time of the investigation.

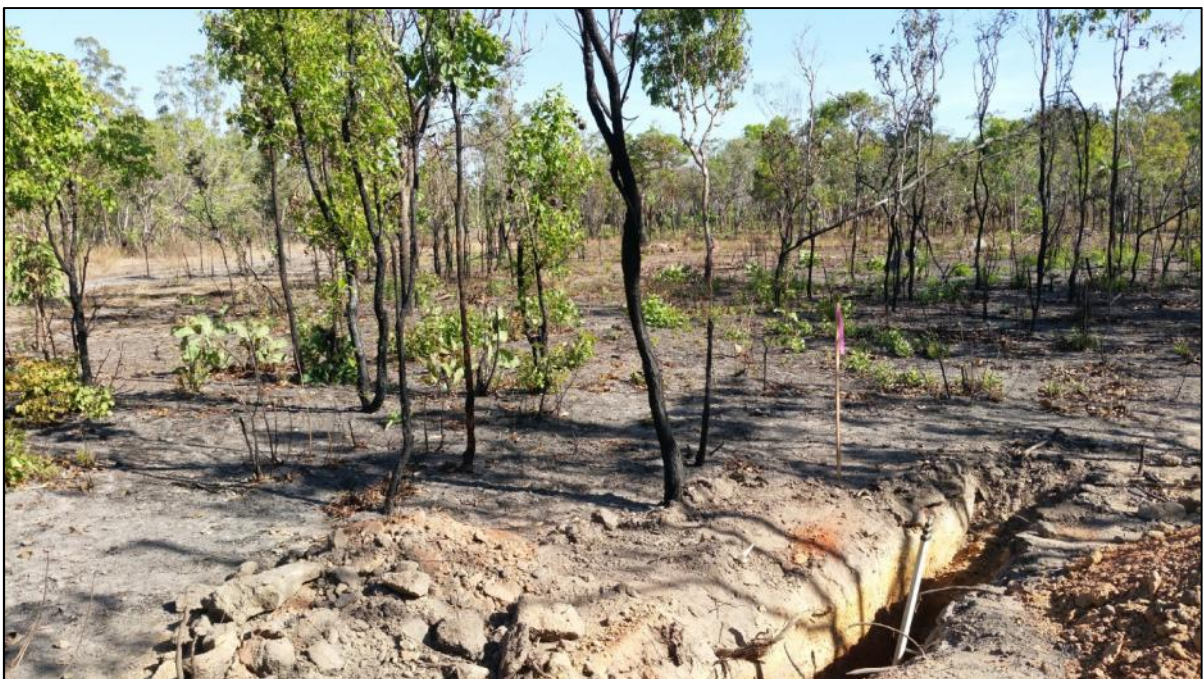
Figure 2 – North-western area of the site, looking northwest

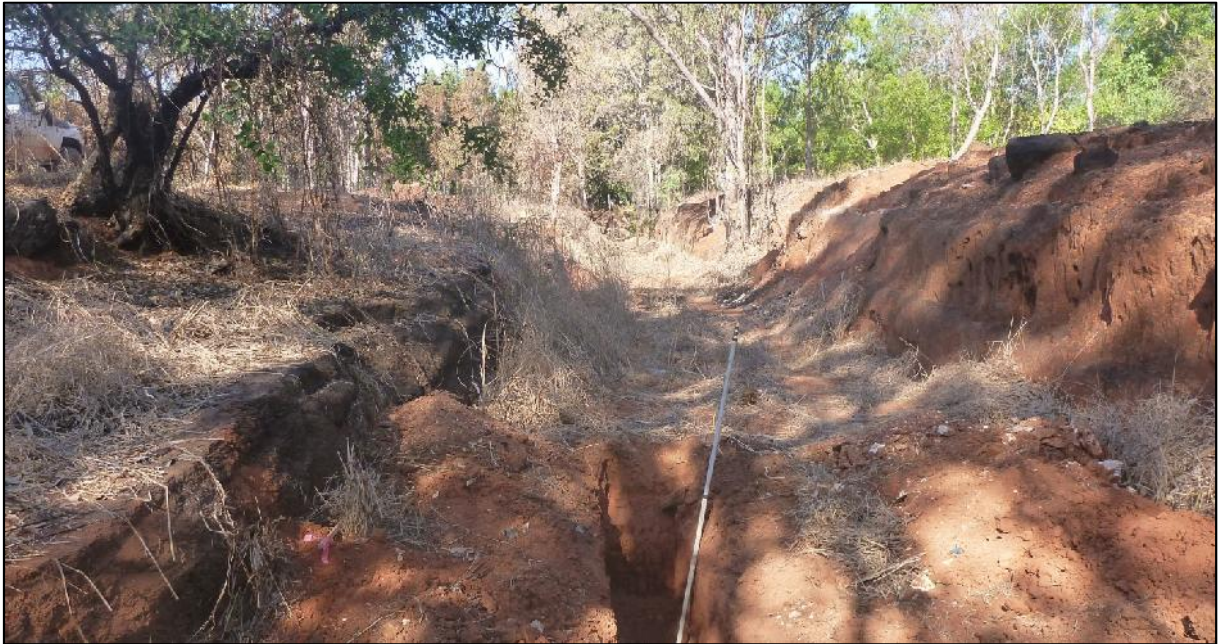
Figure 3 – Existing channel through centre of the site, looking east

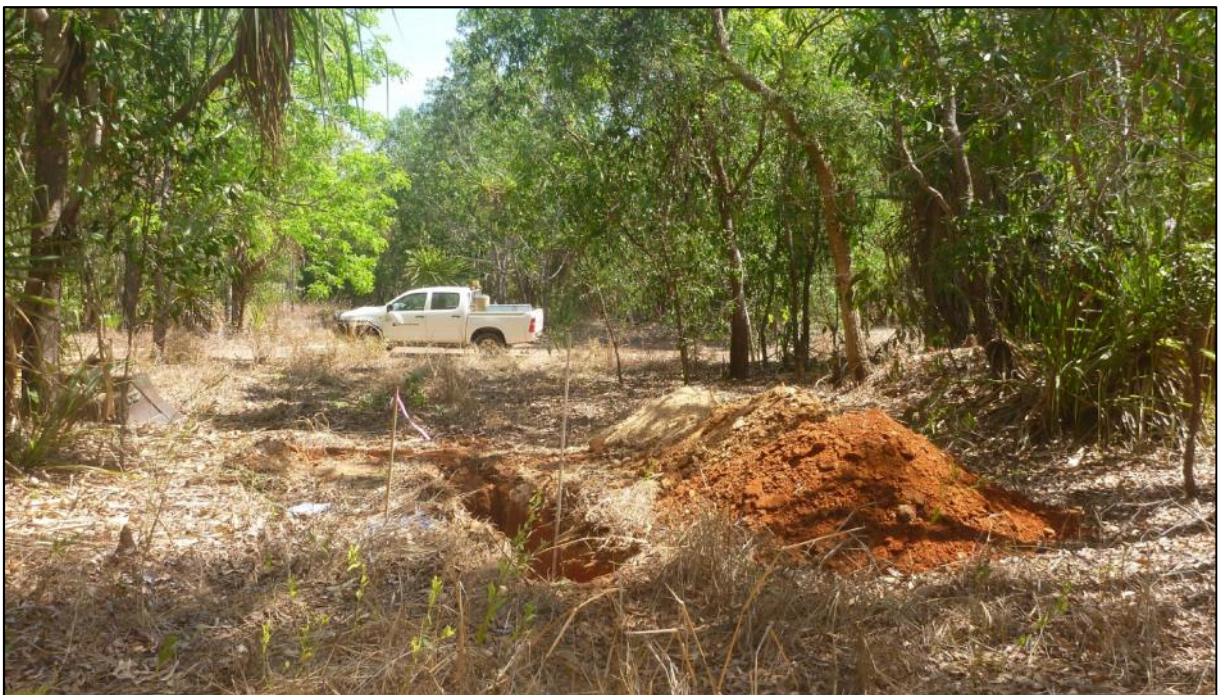
Figure 4 – South-eastern area of the site (east of Henry Wrigley Drive), looking west

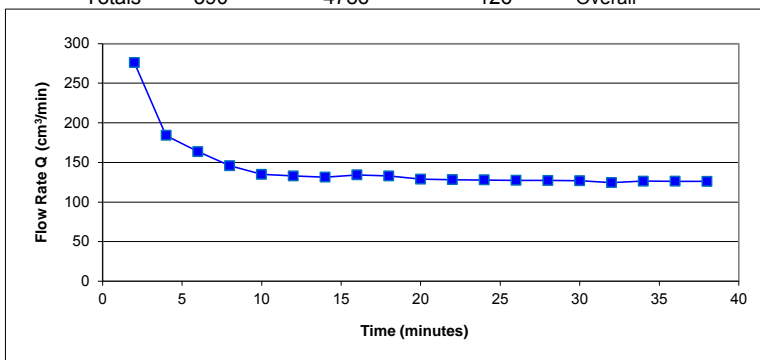
Saturated Hydraulic Conductivity - Over total duration of test

$k = 3.77E-02$ cm/min where $K = 4.4Q[0.5 \sinh^{-1}(H/2r) - \sqrt{[(r/H)^2 + 0.25] + r/H}] / 2\pi H^2$
 $= 6.29E-06$ m/sec ref. AS1547-2012 App G
 $= 0.54$ m/day

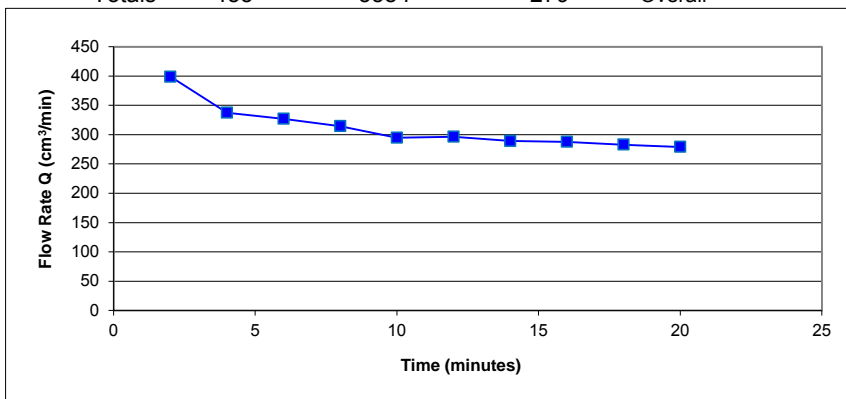
Saturated Hydraulic Conductivity - Over total duration of test

| k = | 7.24E-02 | cm/min | where $K = 4.4Q[0.5 \sinh^{-1}(H/2r) - \sqrt{[(r/H)^2 + 0.25] + r/H}] / 2\pi H^2$ |

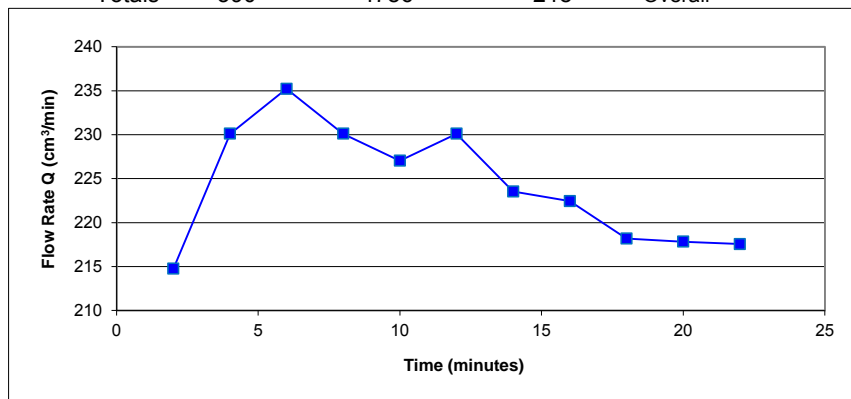
Saturated Hydraulic Conductivity - Over total duration of test

| k = 6.52E-02 | cm/min | where $K = 4.4Q[0.5 \sinh^{-1}(H/2r) - \sqrt{[(r/H)^2 + 0.25] + r/H}] / 2\pi H^2$ |

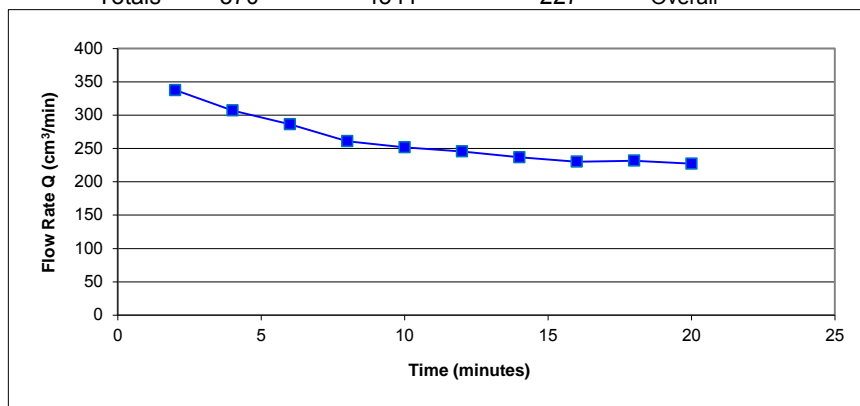
Saturated Hydraulic Conductivity - Over total duration of test

$$\begin{aligned}
 k &= 6.80\text{E-}02 \text{ cm/min} & \text{where } K &= 4.4Q[0.5 \sinh^{-1}(H/2r) - \sqrt{(r/H)^2 + 0.25}] + r/H / 2\pi H^2 \\
 &= 1.13\text{E-}05 \text{ m/sec} & & \text{ref. AS1547-2012 App G} \\
 &= 0.98 \text{ m/day}
 \end{aligned}$$

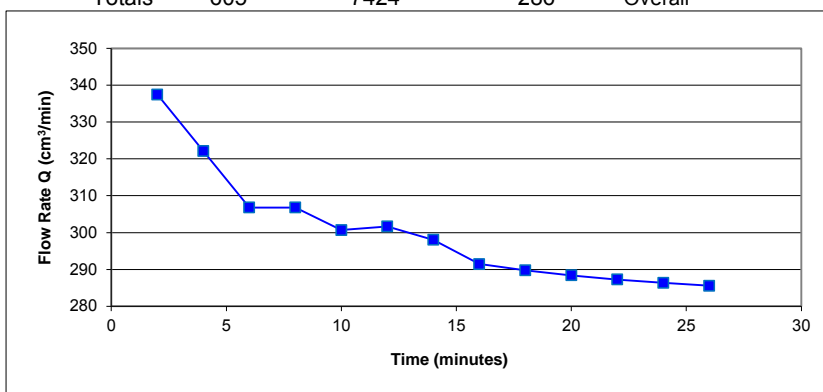
Saturated Hydraulic Conductivity - Over total duration of test

$$\begin{aligned}
 k &= 7.95\text{E-}02 \text{ cm/min} & \text{where } K &= 4.4Q[0.5 \sinh^{-1}(H/2r) - \sqrt{(r/H)^2 + 0.25}] + r/H / 2\pi H^2 \\
 &= 1.32\text{E-}05 \text{ m/sec} & & \text{ref. AS1547-2012 App G} \\
 &= 1.14 \text{ m/day}
 \end{aligned}$$

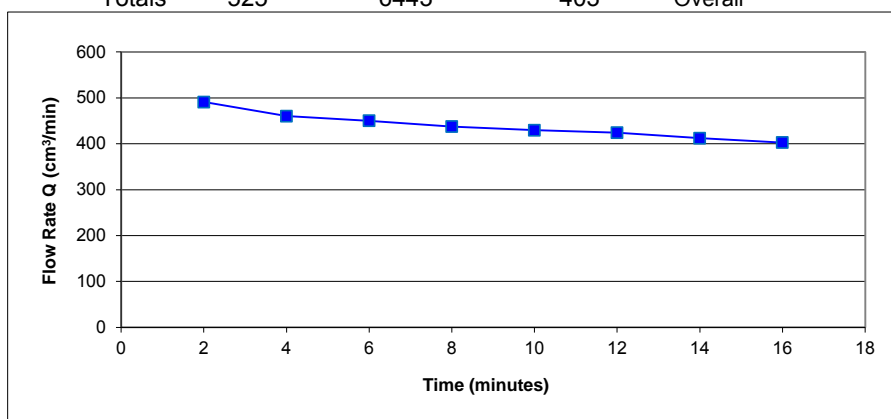
Saturated Hydraulic Conductivity - Over total duration of test

$$\begin{aligned}
 k &= 1.12\text{E-}01 \text{ cm/min} & \text{where } K &= 4.4Q[0.5 \sinh^{-1}(H/2r) - \sqrt{[(r/H)^2 + 0.25] + r/H}] / 2\pi H^2 \\
 &= 1.87\text{E-}05 \text{ m/sec} & & \text{ref. AS1547-2012 App G} \\
 &= 1.61 \text{ m/day}
 \end{aligned}$$

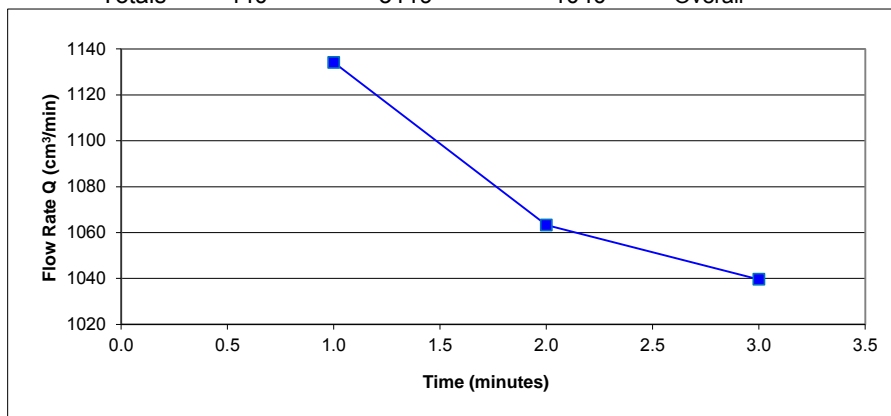
Saturated Hydraulic Conductivity - Over total duration of test

$$\begin{aligned}
 k &= 4.59\text{E-}01 \text{ cm/min} & \text{where } K &= 4.4Q[0.5 \sinh^{-1}(H/2r) - \sqrt{[(r/H)^2 + 0.25] + r/H}] / 2\pi H^2 \\
 &= 7.65\text{E-}05 \text{ m/sec} & & \text{ref. AS1547-2012 App G} \\
 &= 6.61 \text{ m/day}
 \end{aligned}$$

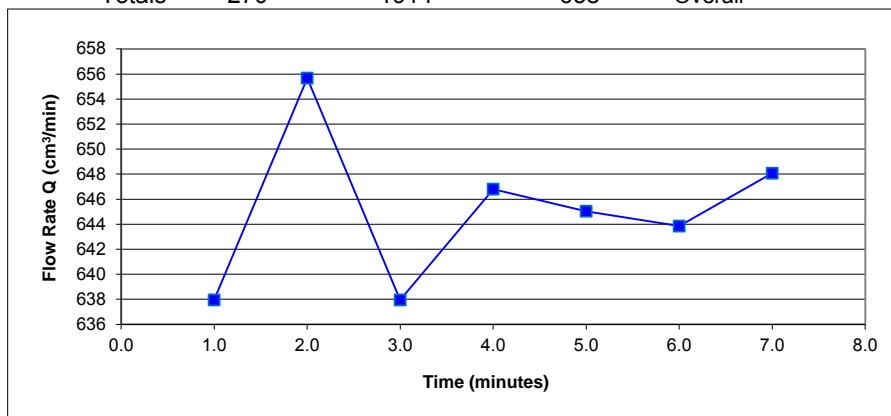
Saturated Hydraulic Conductivity - Over total duration of test

$$\begin{aligned}
 k &= 2.82\text{E-}01 \text{ cm/min} & \text{where } K &= 4.4Q[0.5 \sinh^{-1}(H/2r) - \sqrt{[(r/H)^2 + 0.25] + r/H}] / 2\pi H^2 \\
 &= 4.69\text{E-}05 \text{ m/sec} & & \text{ref. AS1547-2012 App G} \\
 &= 4.06 \text{ m/day}
 \end{aligned}$$

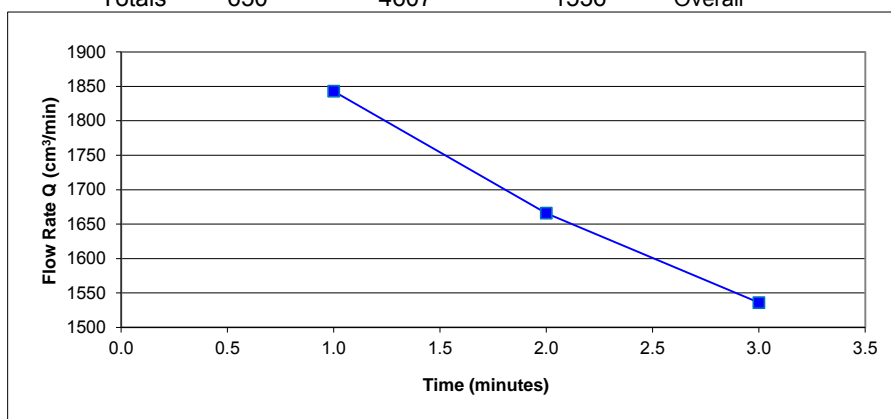
Saturated Hydraulic Conductivity - Over total duration of test

$$\begin{aligned}
 k &= 6.21\text{E-}01 \text{ cm/min} & \text{where } K &= 4.4Q[0.5 \sinh^{-1}(H/2r) - \sqrt{[(r/H)^2 + 0.25] + r/H}] / 2\pi H^2 \\
 &= 1.04\text{E-}04 \text{ m/sec} & & \text{ref. AS1547-2012 App G} \\
 &= 8.94 \text{ m/day}
 \end{aligned}$$

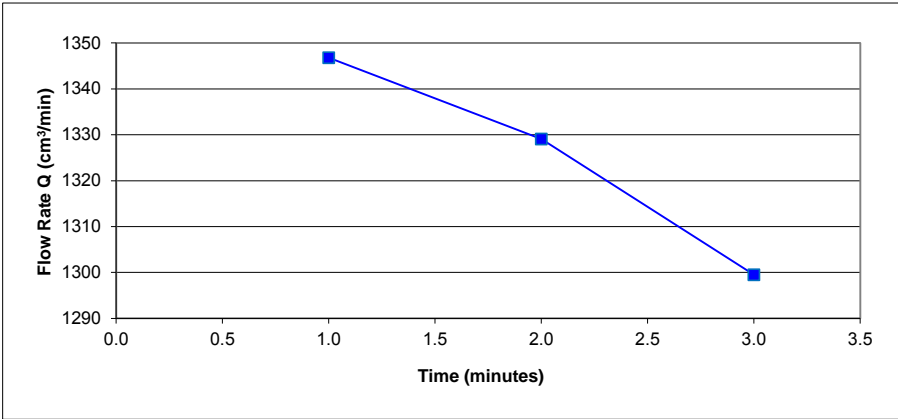
| Client: Jacobs Group (Australia) Pty Ltd Project: Proposed Rapid Creek Flood Mitigation Location: Marrara, NT | Project No: 78245.02 Date: 10-Oct-17 Tested by: BS | | | | | | | | | | | | | | | | | | | | | | | | | | | | | | | | | | | | | | | | | | | | | | | | | | | | | | | | |
|---|--|---|---|---|---|---|---|---|--|---|---|---|---|---|---|---|---|---|---|---|---|--|--|--|--|--|--|--|--|--|--|--|--|--|--|--|--|--|--|--|--|---|---|---|---|---|--|--|--|---|---|---|---|---|---|---|---|
| Test Location Description: Test Pit 126, at surface Material type: Brown and yellow brown, Silty Sand Condition of ground surface before test: Humid Weather during test: Fine and sunny | Test No. 126A Easting: 703976 m Northing: 8628713 m Surface Level: - m AHD | | | | | | | | | | | | | | | | | | | | | | | | | | | | | | | | | | | | | | | | | | | | | | | | | | | | | | | | |
| Details of Bore Installation Depth of augered hole: 500 mm Depth of constant water below permeameter: 320 mm Diameter of hole: 95 mm Depth to impermeable layer: - m Time from filling to start: 0.5 minutes | | | | | | | | | | | | | | | | | | | | | | | | | | | | | | | | | | | | | | | | | | | | | | | | | | | | | | | | | |
| Test Results <table border="1" style="width: 100%; border-collapse: collapse; margin-top: 10px;"> <thead> <tr> <th>Time (minutes)</th> <th>Level below top (mm)</th> <th>Flow Volume (cm³)</th> <th>Rate of Loss [Q] (cm³/min)</th> </tr> </thead> <tbody> <tr><td>0</td><td>0</td><td>0</td><td></td></tr> <tr><td>1.0</td><td>190</td><td>1347</td><td>1347</td></tr> <tr><td>2.0</td><td>375</td><td>2658</td><td>1329</td></tr> <tr><td>3.0</td><td>550</td><td>3899</td><td>1300</td></tr> <tr><td> </td><td> </td><td> </td><td> </td></tr> <tr><td> </td><td> </td><td> </td><td> </td></tr> <tr><td> </td><td> </td><td> </td><td> </td></tr> <tr><td> </td><td> </td><td> </td><td> </td></tr> <tr><td> </td><td> </td><td> </td><td> </td></tr> <tr> <td>Totals</td> <td>550</td> <td>3899</td> <td>1300</td> </tr> <tr> <td colspan="4" style="text-align: right;">Overall</td> </tr> </tbody> </table> <div style="margin-top: 10px;"> <table border="1" style="width: 100%; border-collapse: collapse; margin-top: 5px;"> <caption>Graph Data Points</caption> <thead> <tr> <th>Time (minutes)</th> <th>Flow Rate Q (cm³/min)</th> </tr> </thead> <tbody> <tr><td>1.0</td><td>1347</td></tr> <tr><td>2.0</td><td>1329</td></tr> <tr><td>3.0</td><td>1300</td></tr> </tbody> </table> </div> | | Time (minutes) | Level below top (mm) | Flow Volume (cm ³) | Rate of Loss [Q] (cm ³ /min) | 0 | 0 | 0 | | 1.0 | 190 | 1347 | 1347 | 2.0 | 375 | 2658 | 1329 | 3.0 | 550 | 3899 | 1300 | | | | | | | | | | | | | | | | | | | | | Totals | 550 | 3899 | 1300 | Overall | | | | Time (minutes) | Flow Rate Q (cm ³ /min) | 1.0 | 1347 | 2.0 | 1329 | 3.0 | 1300 |

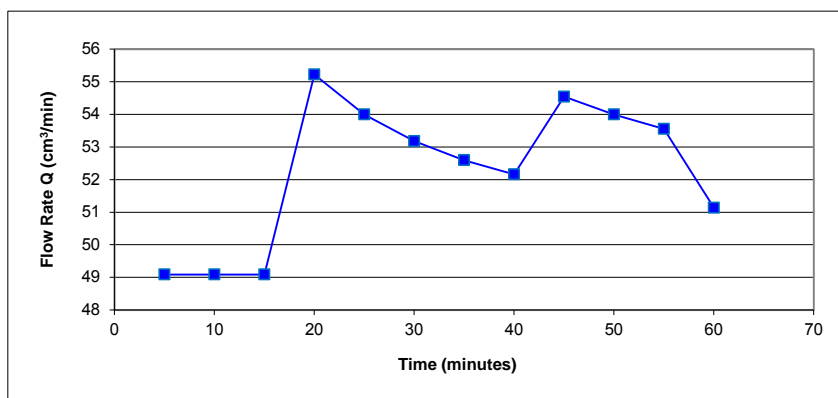
Saturated Hydraulic Conductivity - Over total duration of test

$$k = 2.37E-02 \text{ cm/min} \quad \text{where } K = 4.4Q[0.5 \sinh^{-1}(H/2r) - \sqrt{[(r/H)^2 + 0.25]} + r/H]/2\pi H^2$$

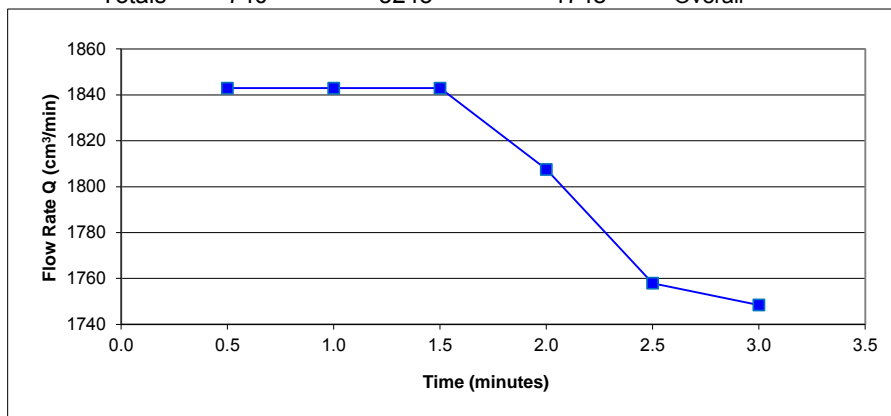
Saturated Hydraulic Conductivity - Over total duration of test

$$\begin{aligned}
 k &= 6.01\text{E-}01 \text{ cm/min} & \text{where } K &= 4.4Q[0.5 \sinh^{-1}(H/2r) - \sqrt{[(r/H)^2 + 0.25] + r/H}] / 2\pi H^2 \\
 &= 1.00\text{E-}04 \text{ m/sec} & & \text{ref. AS1547-2012 App G} \\
 &= 8.65 \text{ m/day}
 \end{aligned}$$

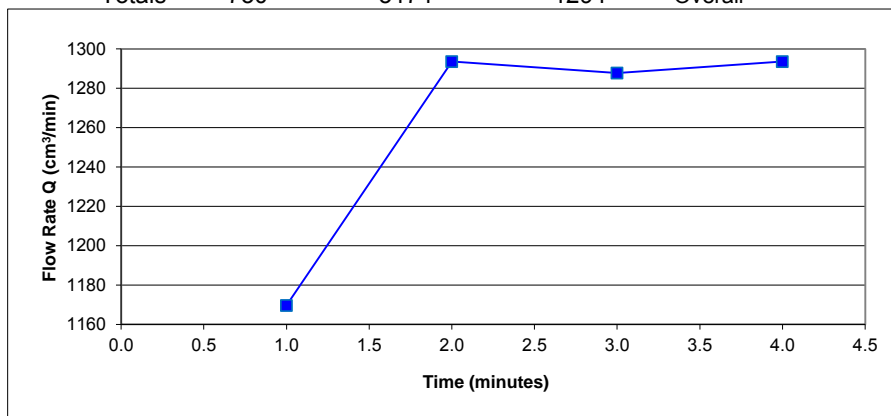
Saturated Hydraulic Conductivity - Over total duration of test

$$\begin{aligned}
 k &= 4.45\text{E-}01 \text{ cm/min} & \text{where } K &= 4.4Q[0.5 \sinh^{-1}(H/2r) - \sqrt{[(r/H)^2 + 0.25]} + r/H]/2\pi H^2 \\
 &= 7.41\text{E-}05 \text{ m/sec} & & \text{ref. AS1547-2012 App G} \\
 &= 6.40 \text{ m/day}
 \end{aligned}$$

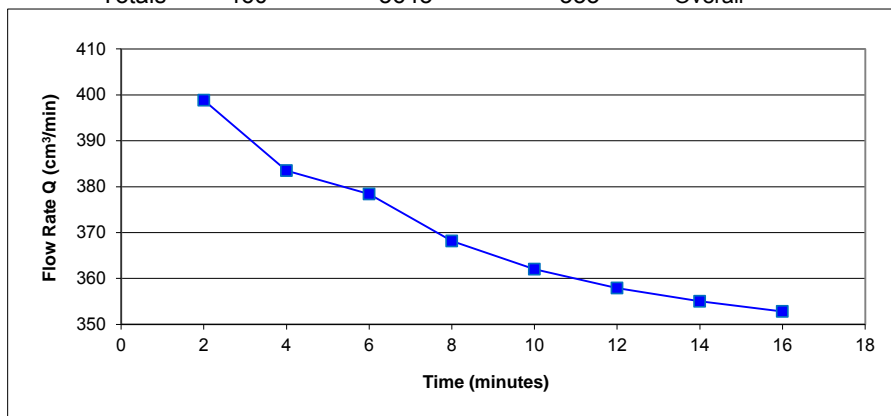
Saturated Hydraulic Conductivity - Over total duration of test

$$\begin{aligned}
 k &= 1.06\text{E-}01 \quad \text{cm/min} & \text{where } K &= 4.4Q[0.5 \sinh^{-1}(H/2r) - \sqrt{[(r/H)^2 + 0.25] + r/H}] / 2\pi H^2 \\
 &= 1.76\text{E-}05 \quad \text{m/sec} & & \text{ref. AS1547-2012 App G} \\
 &= 1.52 \quad \text{m/day}
 \end{aligned}$$

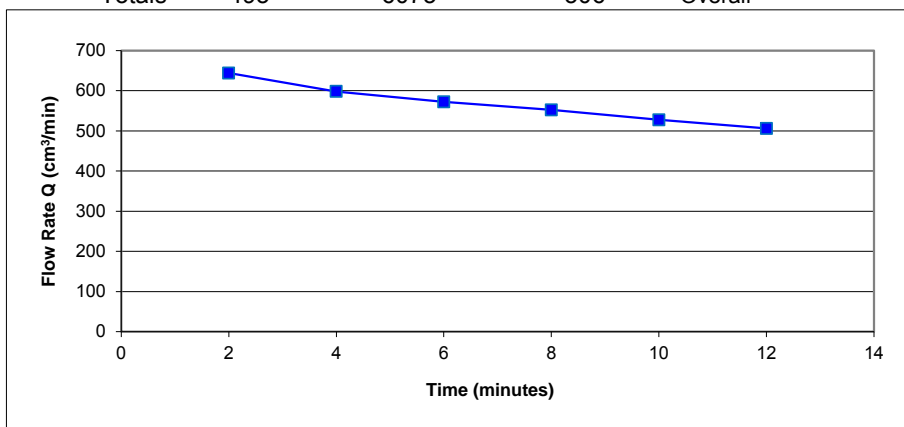
Saturated Hydraulic Conductivity - Over total duration of test

$$k = 1.52E-01 \text{ cm/min} \quad \text{where } K = 4.4Q[0.5 \sinh^{-1}(H/2r) - \sqrt{[(r/H)^2 + 0.25] + r/H}] / 2\pi H^2$$

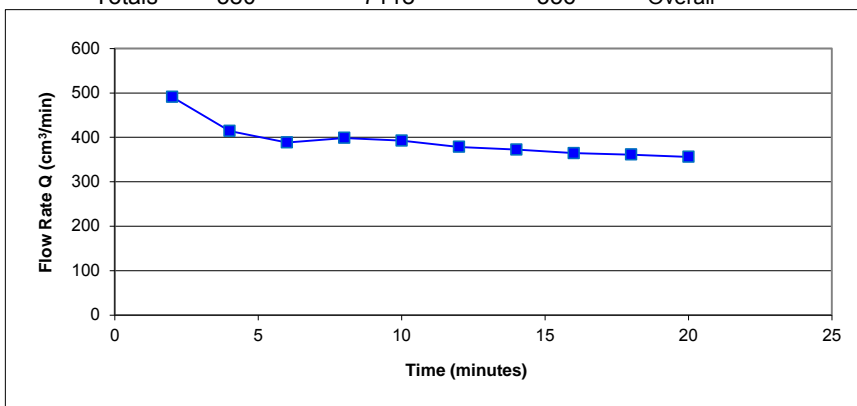
Saturated Hydraulic Conductivity - Over total duration of test

$$\begin{aligned}
 k &= 1.07\text{E-}01 \quad \text{cm/min} & \text{where } K &= 4.4Q[0.5 \sinh^{-1}(H/2r) - \sqrt{(r/H)^2 + 0.25}] + r/H / 2\pi H^2 \\
 &= 1.78\text{E-}05 \quad \text{m/sec} & & \text{ref. AS1547-2012 App G} \\
 &= 1.54 \quad \text{m/day}
 \end{aligned}$$

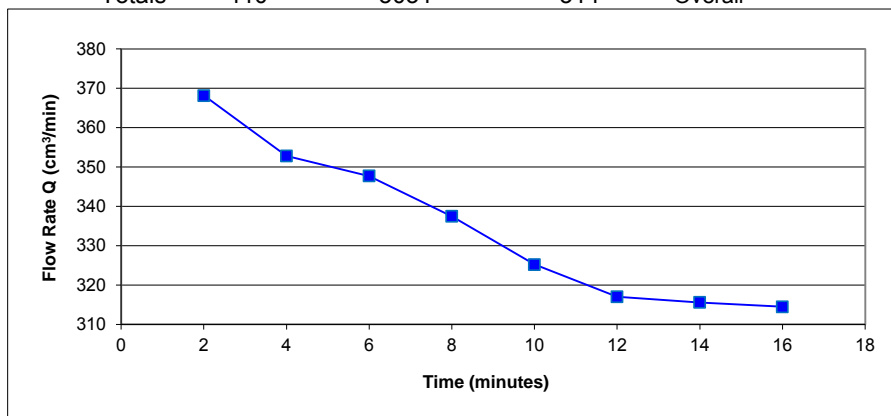
Saturated Hydraulic Conductivity - Over total duration of test

$$\begin{aligned}
 k &= 9.42\text{E-}02 \text{ cm/min} & \text{where } K &= 4.4Q[0.5 \sinh^{-1}(H/2r) - \sqrt{[(r/H)^2 + 0.25] + r/H}] / 2\pi H^2 \\
 &= 1.57\text{E-}05 \text{ m/sec} & & \text{ref. AS1547-2012 App G} \\
 &= 1.36 \text{ m/day}
 \end{aligned}$$

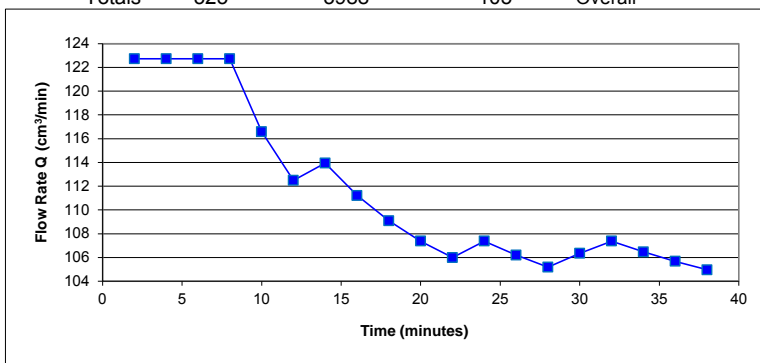
Saturated Hydraulic Conductivity - Over total duration of test

$k = 4.85E-02$ cm/min where $K = 4.4Q[0.5 \sinh^{-1}(H/2r) - \sqrt{[(r/H)^2 + 0.25] + r/H}] / 2\pi H^2$
 $= 8.09E-06$ m/sec ref. AS1547-2012 App G
 $= 0.70$ m/day
