2. SITE INVENTORY AND ASSESSMENT

2.1 PHYSICAL ENVIRONMENT

2.1.1 CREEK HYDROLOGY

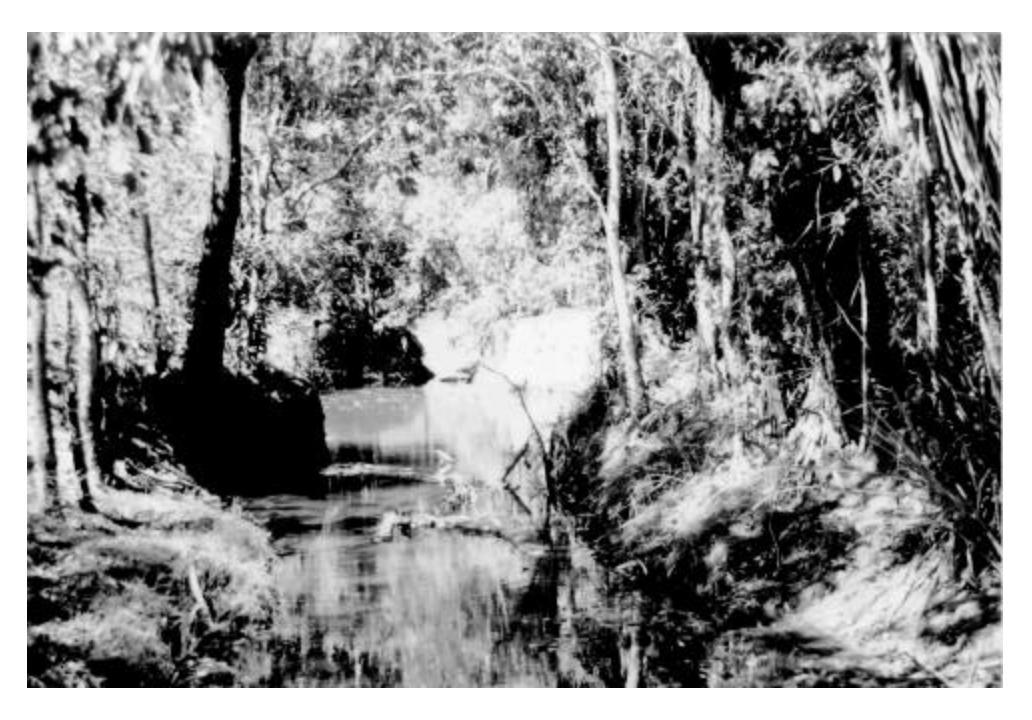
Rapid Creek follows a well defined channel through the riverine monsoon forest, where low flows persist well into the dry season.

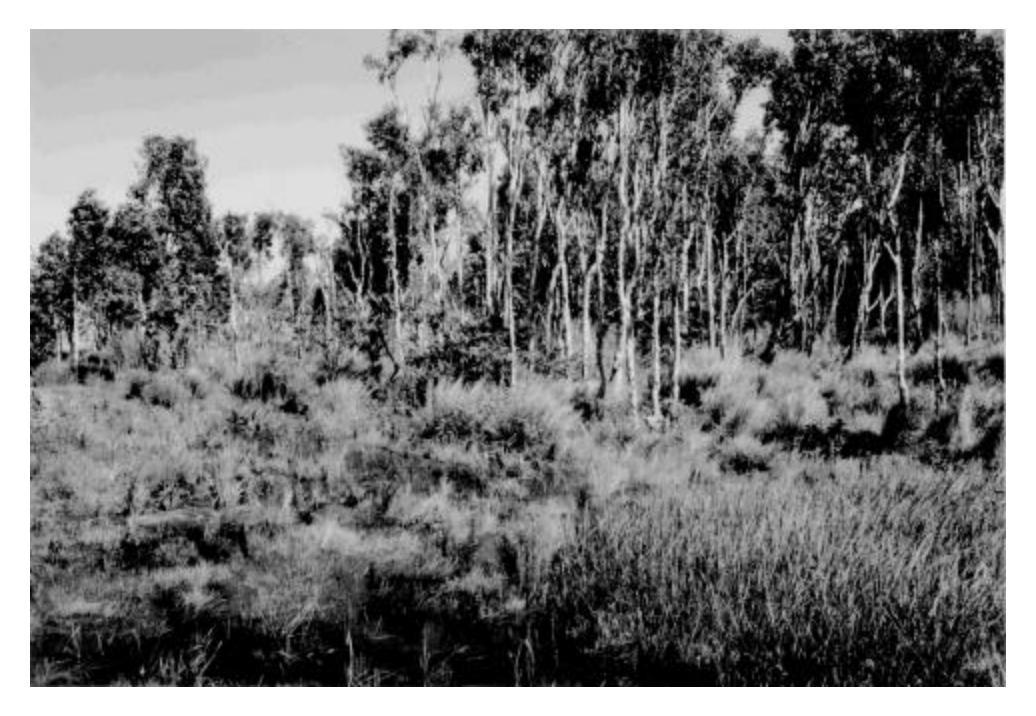
The paperbark swamp area on the southern arm of Rapid Creek is an important component in the overall flood mitigation role of the upper catchment.

The swamps, in conjunction with the well-vegetated, ill-defined channels of the north and south arms serve a major role in flood control and mitigation (Cameron McNamara, 1982). The road crossings at McMillans and Trower Roads were designed to a minimum standard that they should not be flooded more frequently than once in 20 years on average. However, with changes in the catchment upstream of Kimmorley Bridge, it is likely that McMillans Road would flood more frequently than this (Cameron McNamara, 1982) and there is anecdotal evidence of this. The same report goes on to note that the upper catchment of Rapid Creek is the major control on reducing peak flows and maximum flood levels. This role is dependent on maintaining the 'unimproved' nature of the creek.

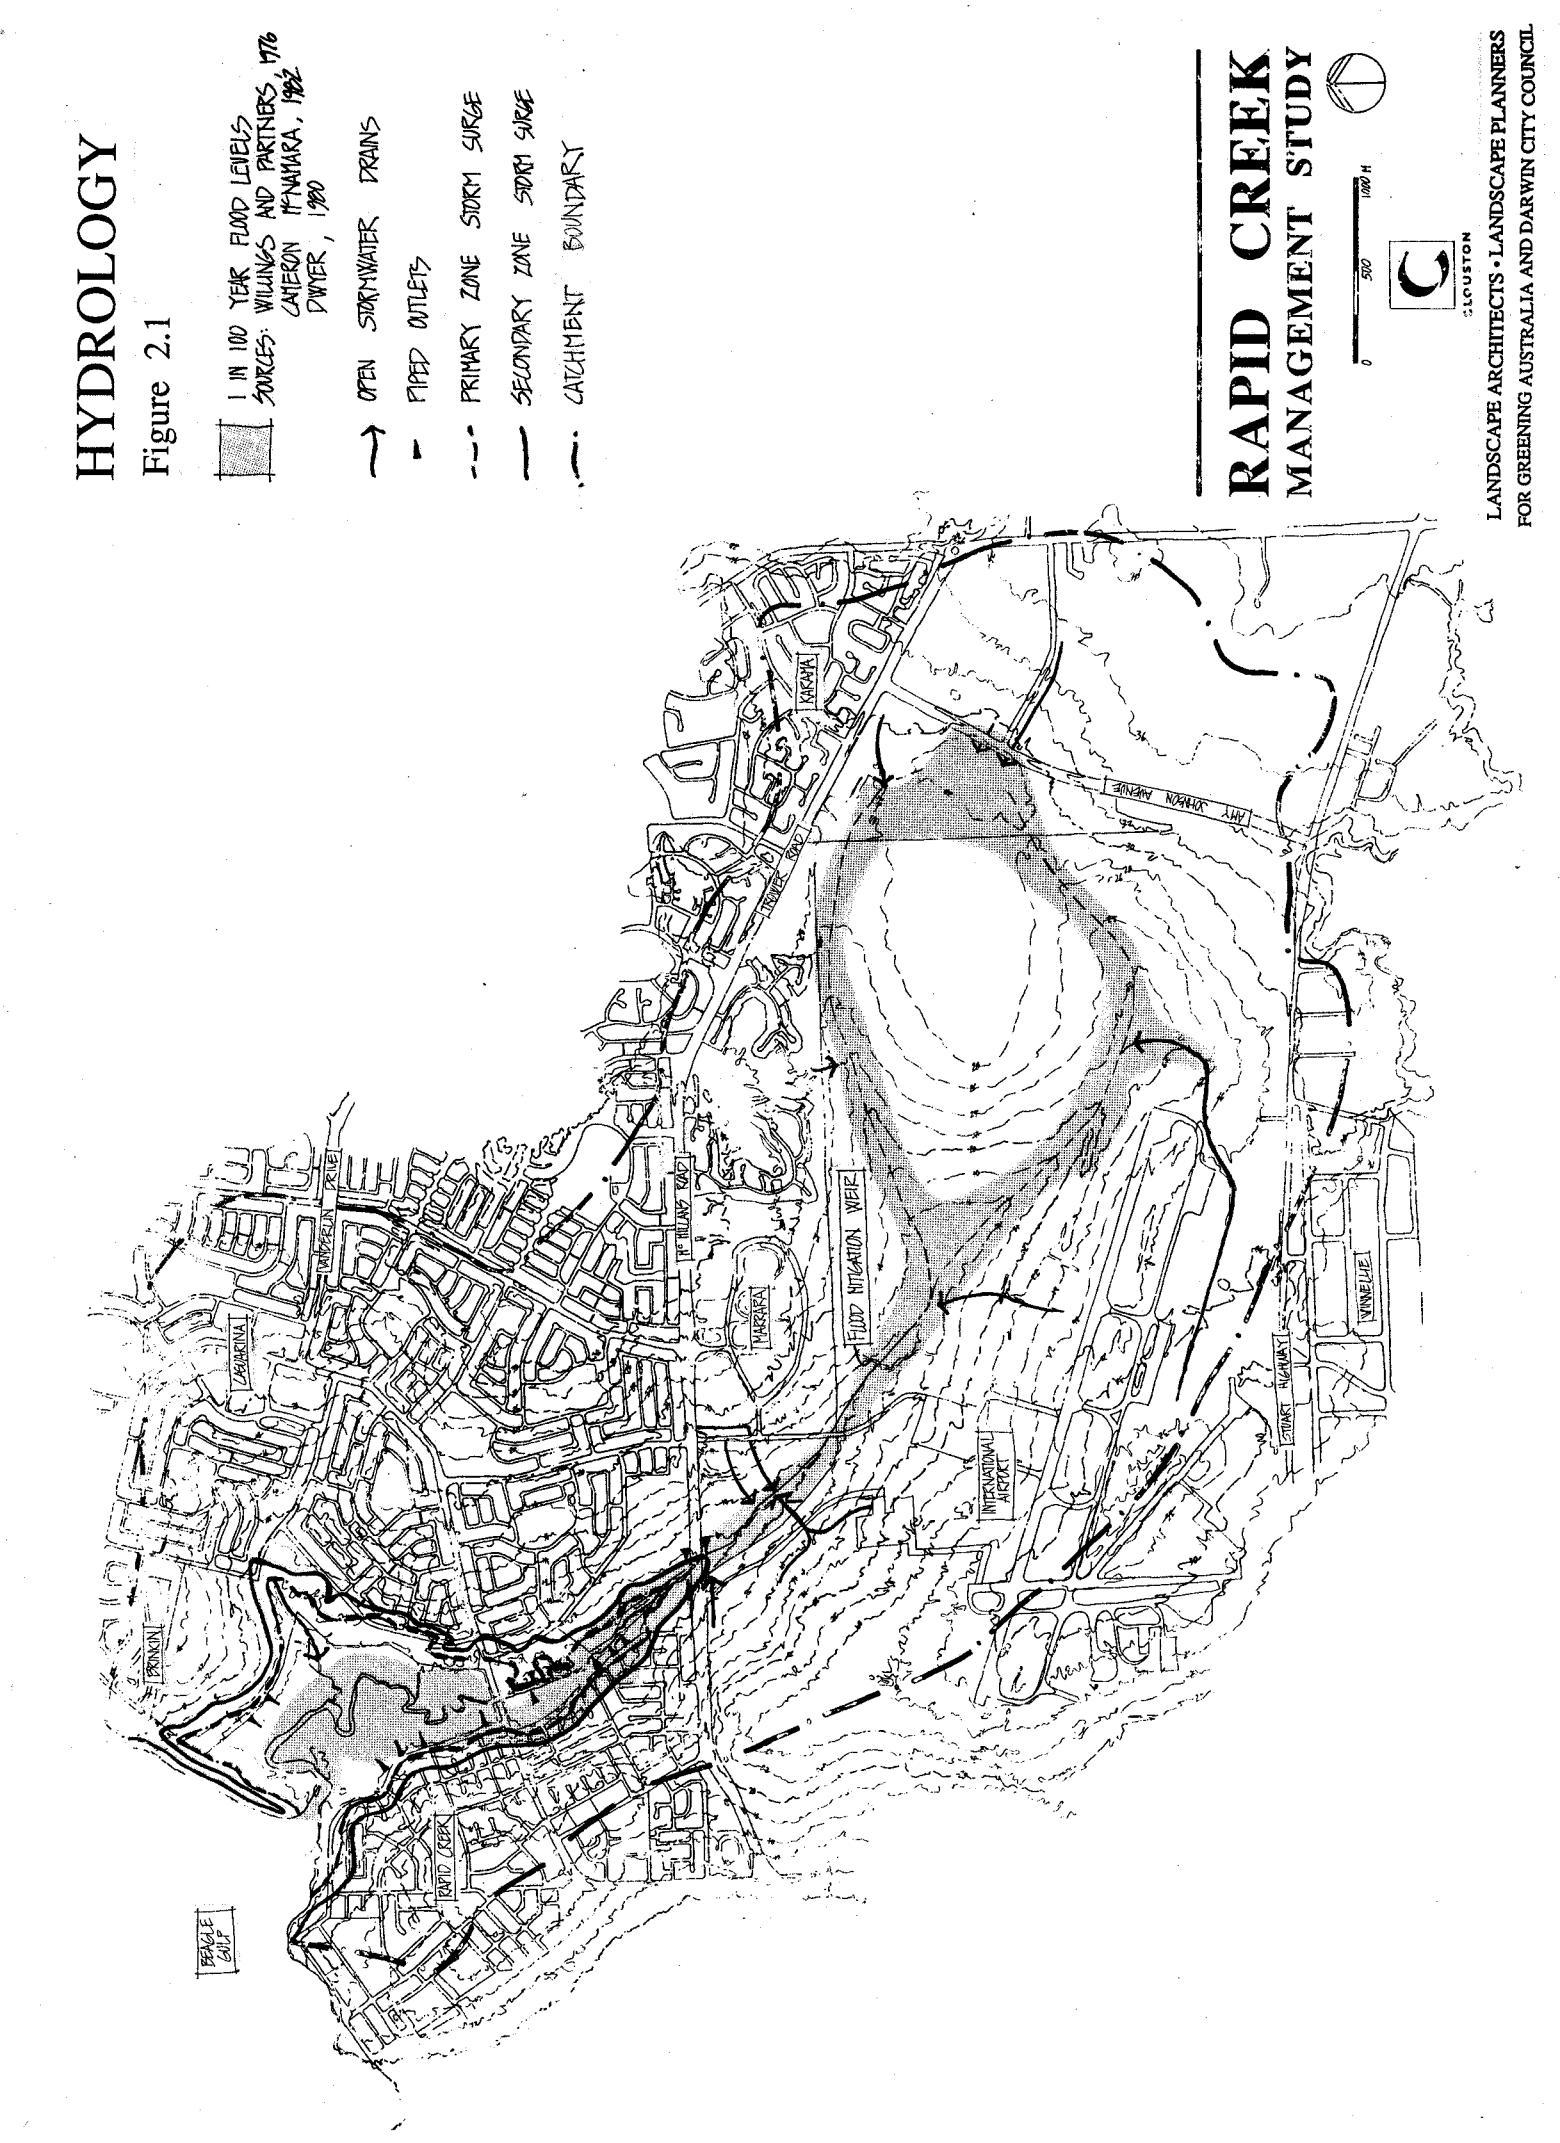
This study looks at the entire catchment area of the Rapid Creek. The Creek, measured from Marrara Swamp to the mouth at Casuarina Coastal Reserve is approximately 9.8 km in length, draining a catchment of over 28 km^2 as shown in Figure 2.1

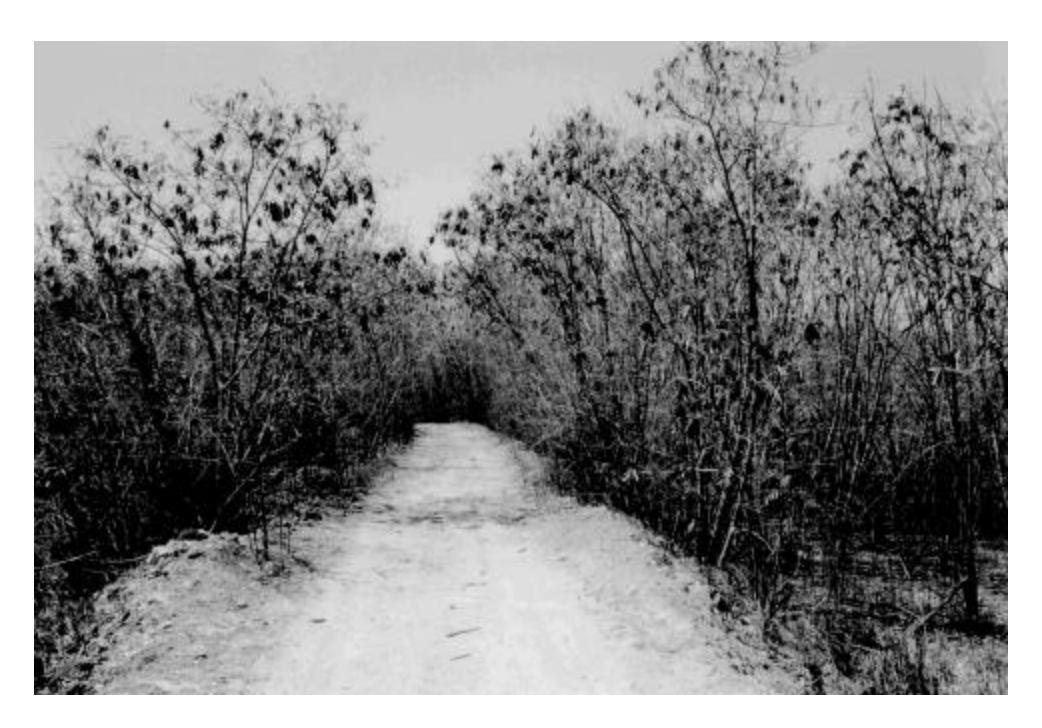
Coffee bush infestation on disturbed land adjoining Northern Territory University and mangrove community.

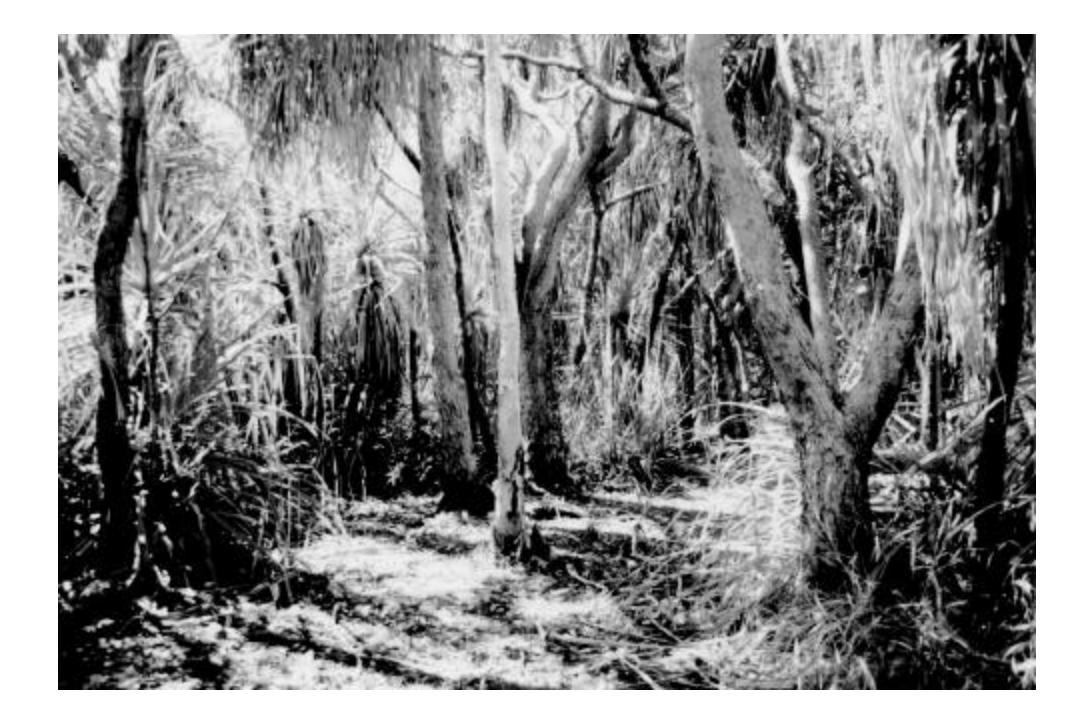
Healthy pandanus community on northern area of Rapid Creek.

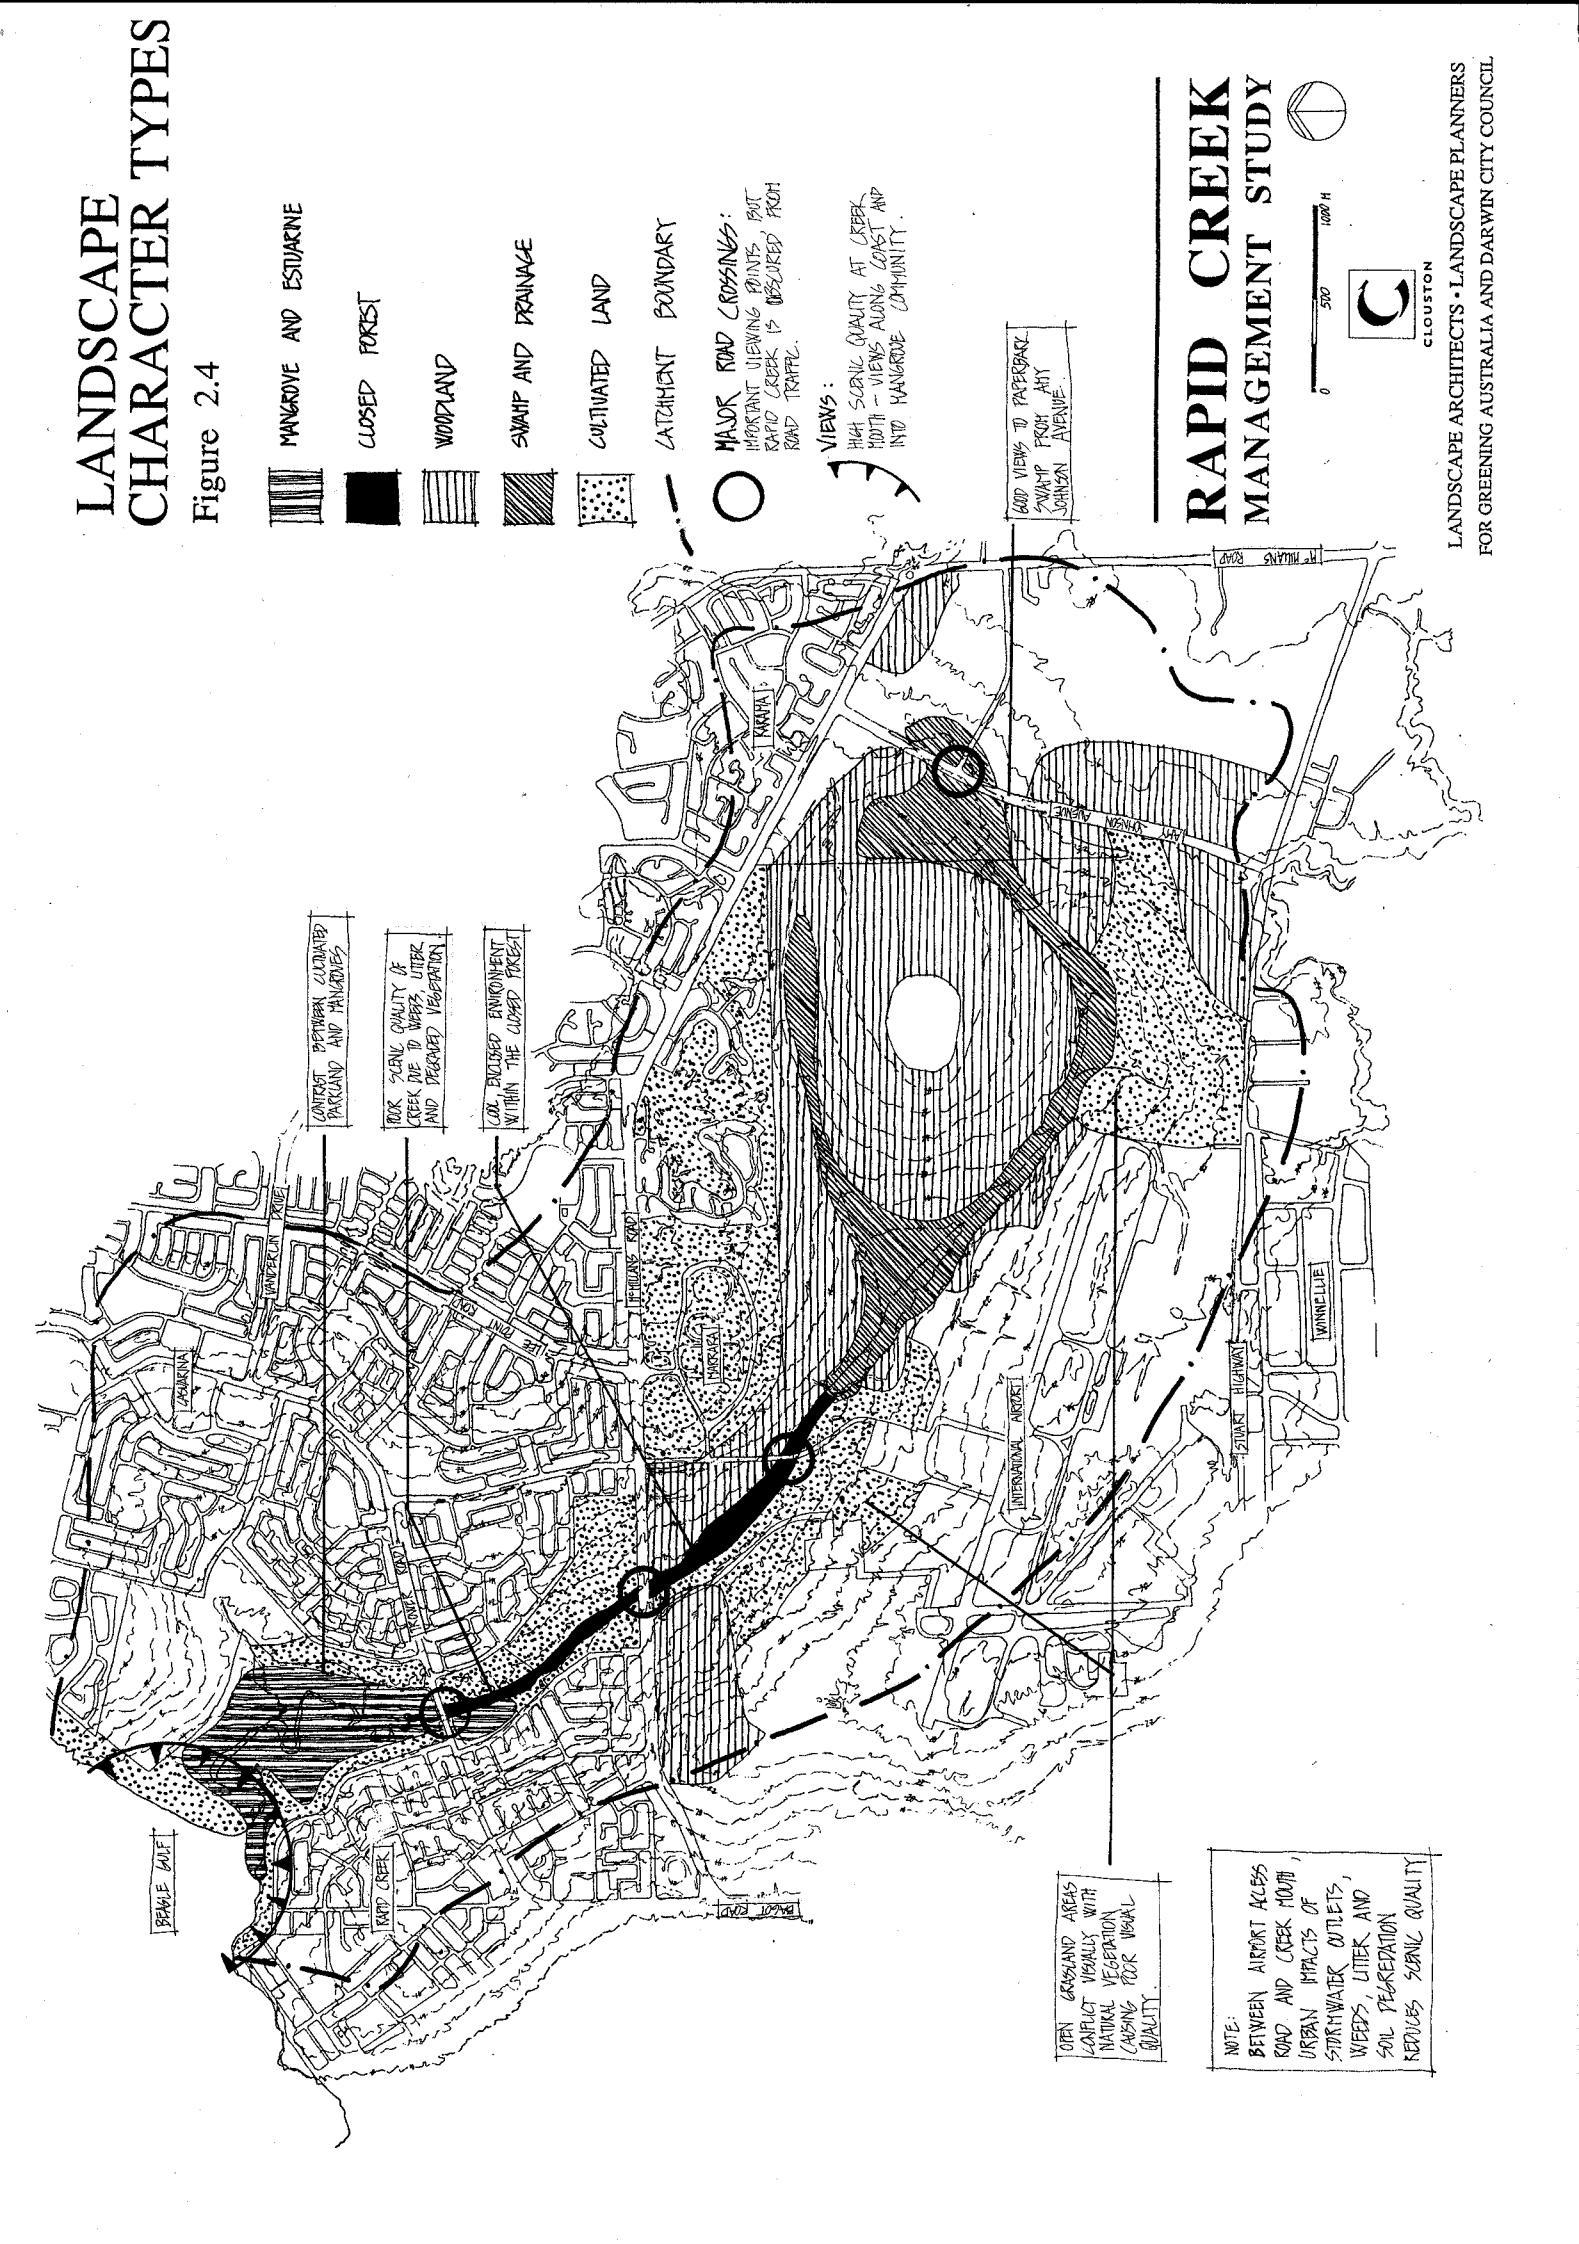
Within each character type a number of landscape settings have been identified based on water characteristics, vegetation communities, and topographic profile of the creek. These are described and illustrated below. Their location in the catchment is shown in Figure 2.4.

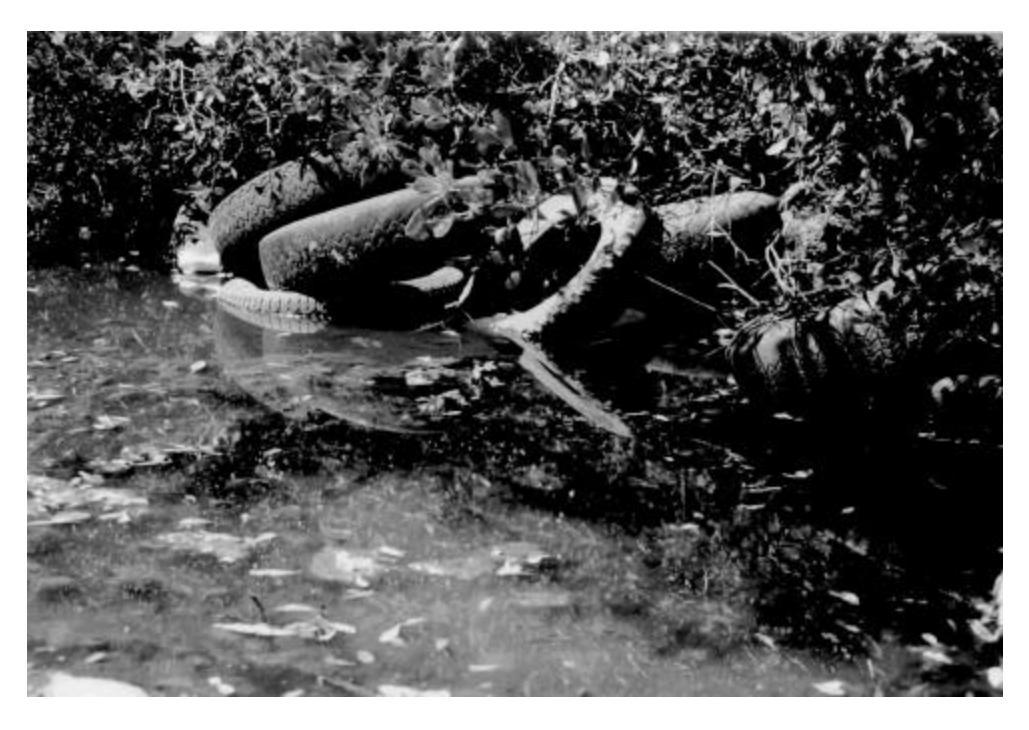
Littering, rubbish dumping, poor water quality and weed encroachment all have a negative impact on the scenic quality.

- Rubbish dumping, in particular littering of cans, bottles and papers.
- Indiscriminate car parking and access tracks, with corresponding loss of ground cover and erosion (sheet, gully, rill).
- Degradation of vegetation, loss of canopy and significant weed invasion.
- Low flows from urban stormwater systems.
- Inappropriate development that is often poorly sited and designed, with inadequate attention given to the necessary rehabilitation of disturbed areas.
