3. Biological Indicators for freshwater systems.

3.1 Rapid Creek 2015

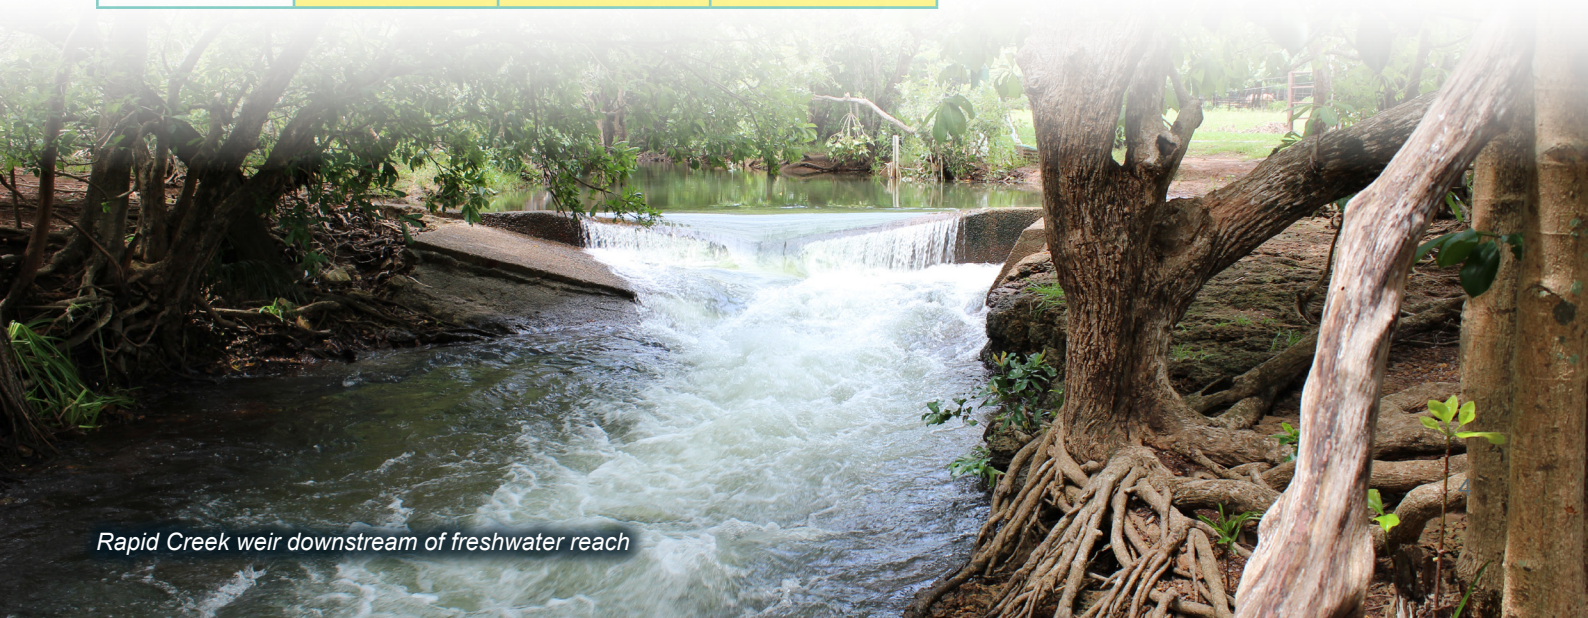
Rapid Creek weir downstream of freshwater reach
